*MASH TL3 EVALUATION OF  
MASSDOT'S CM-MTL3 BRIDGE RAIL  
USING FINITE ELEMENT ANALYSIS*

Prepared for: **Gill Engineering and the Massachusetts Department of  
Transportation**

Project No: **X129053P11 - PHASE IV**

July 30, 2021

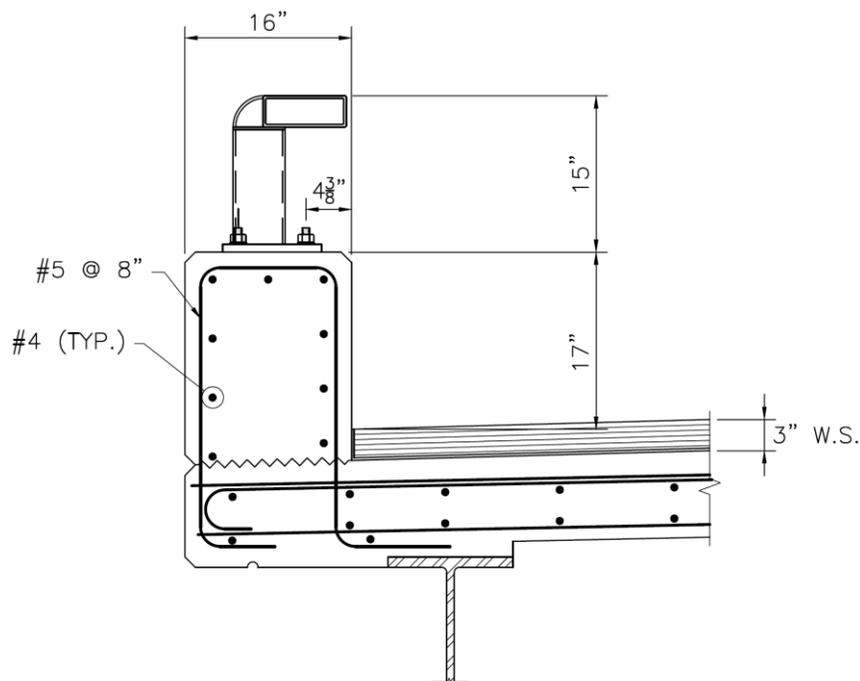
**Figure 1. Section drawing for CM-MTL3.**

Drawings details for the modified design for the CM-MTL3 are shown in Appendix A. The design includes a 15-1/8 inches tall steel post-and-beam railing mounted onto the top of a 17-inch tall continuous reinforced concrete barrier, as illustrated in Figures 1-3. The overall height of the barrier is 32-1/8 inches measured from the top of the roadway to the top of the steel rail. The steel post-and-beam rail is composed of a HSS 8"x3"x1/4" longitudinal beam supported by HSS 5"x5"x1/4" posts which are spaced at 6 feet on centers. The longitudinal beam is welded to the top of the posts. A 3/4-inch thick steel base plate is welded to the bottom of each post, and the base plate is fastened to the top of the curb or sidewalk using four 3/4-inch diameter ASTM A4495 anchor bolts that are 12-inch long, as shown in Figure 2. Two bolts are positioned on the front side of the posts and two bolts positioned at the back of the base plate and closely aligned with the back edge of the posts. A 3/8" x 9 1/2" x 1 1/2" anchor plate is attached at the bottom of the anchor bolts to secure the anchors and to prevent pullout during impact.

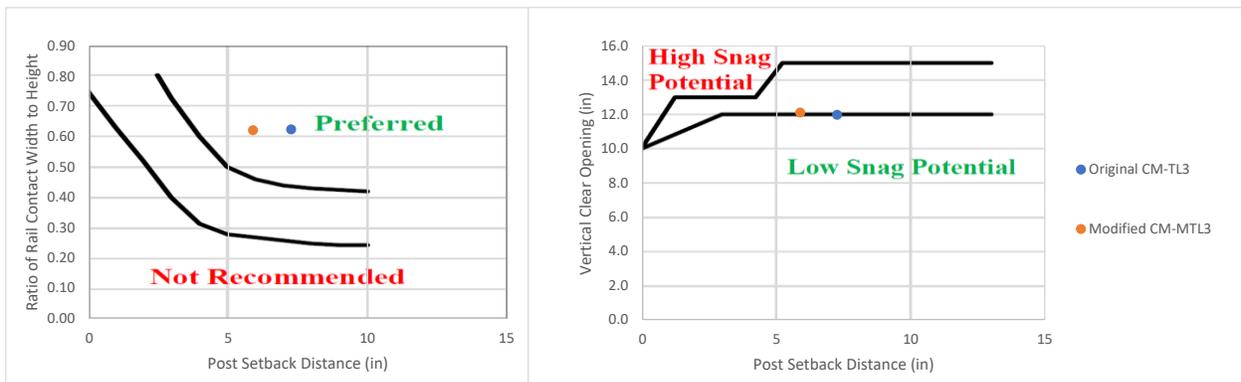
**Figure 4. AASHTO Section 13 Figures A13.1.1-2 and A13.1.1-3 including Original CM-TL3 and Modified CM-MTL3.**

The most significant change for the modified CM-MTL3 design compared to the original CM-TL3 design is a decreased offset distance for the post. The offset distance is 5-7/8" for the CM-MTL3 compared to 7-1/4" for the original CM-TL3. Geometric evaluation criteria for bridge railings are contained in Figures A13.1.1-2 and A13.1.1-3 of Section 13 of the AASHTO LRFD Bridge Design Specifications and are reproduced here in Figure 4 for convenience.[AASHTO12] The geometric criteria were developed based on a review of NCHRP Report 230 crash test data to relate impact performance to the geometric characteristics of bridge railing systems. The rail geometric criteria correlate the potential for the wheel, bumper, or hood to snag against a bridge rail post during impact, which could potentially lead to high vehicle decelerations and occupant compartment intrusions. These criteria have not yet been correlated to *MASH* criteria but are still commonly applied to bridge rail design. The rail-geometric assessment for the original and modified designs are illustrated in Figure 4, which shows that both designs meet preferred conditions for the *ratio of rail contact width to height* relative to *post setback distance* and are both borderline for preferred-marginal for the *vertical clear opening* relative to *post setback distance* criteria.

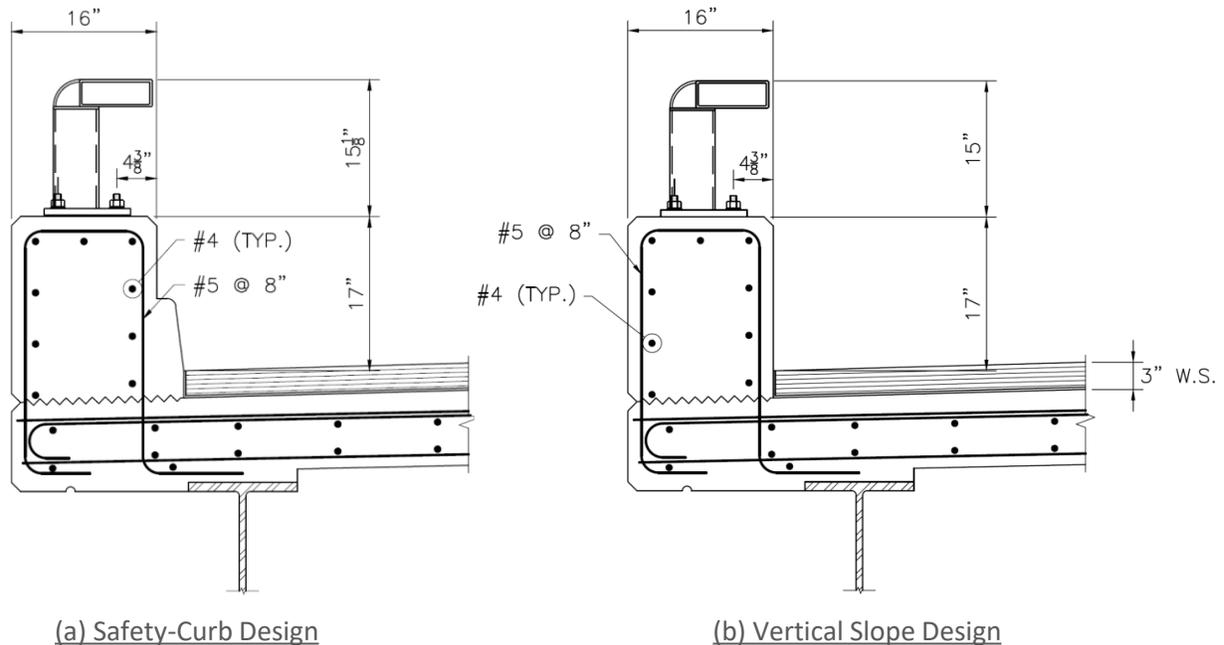
**Figure 5. Section drawing for (a) safety-curb design and (b) vertical slope design.**

The objective of this project was to use finite element analysis (FEA) computer simulation to evaluate the crash performance of the MassDOT CM-MTL3 bridge rail design under the current impact and evaluation criteria of *MASH* TL3. The crash evaluations were carried out using the non-linear, dynamic, explicit finite element analysis software LS-DYNA. [LSDYNA17]. The assessment procedures included evaluations of structural capacity, risk of occupant injury and vehicle stability during impact and redirection. Two design options were evaluated: (1) integral safety-curb on concrete barrier and (2) vertical slope on concrete barrier, as shown in Figure 5.

Based on the results presented in Chapter 5, the CM-MTL3 design was modified to improve crash performance by replace the integral curb on the face of the barrier with a vertical face design, as shown in Figure 5. FEA was again used to evaluate the crash performance of the bridge rail under MASH TL3 performance criteria. The evaluations included:

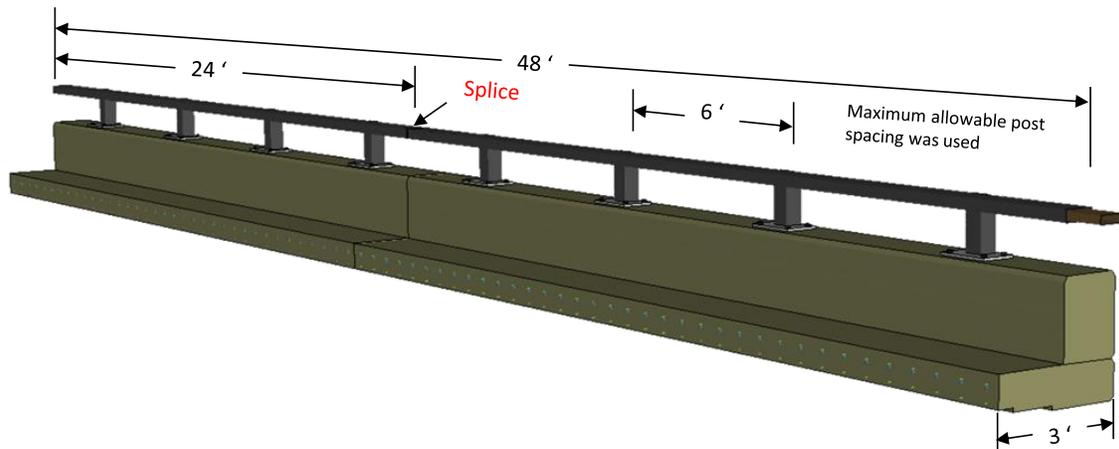
**Figure 9. FEA model of the MassDOT CM-MTL3 bridge rail.**

- Eight (8) 5”x5”x1/4” posts spaced at 6-feet on centers,
- Eight (8) 9.5”x14.25”x0.75” base plates (i.e., one at each post),
- Eight (8) 9.5”x14.5”x0.375” anchor plates (i.e., one at each post)
- Thirty-two (32) anchor bolts (i.e., four (4) at each base plate connecting the base plate to the concrete parapet),
- Two (2) HSS 8”x3”x0.25” tube rails that are 24 feet long (each) and hardware,
- One (1) splice tube weldment, 18 inches long (each) made from 1/4-inch thick steel plate, and
- Concrete parapet and bridge deck with steel reinforcement.

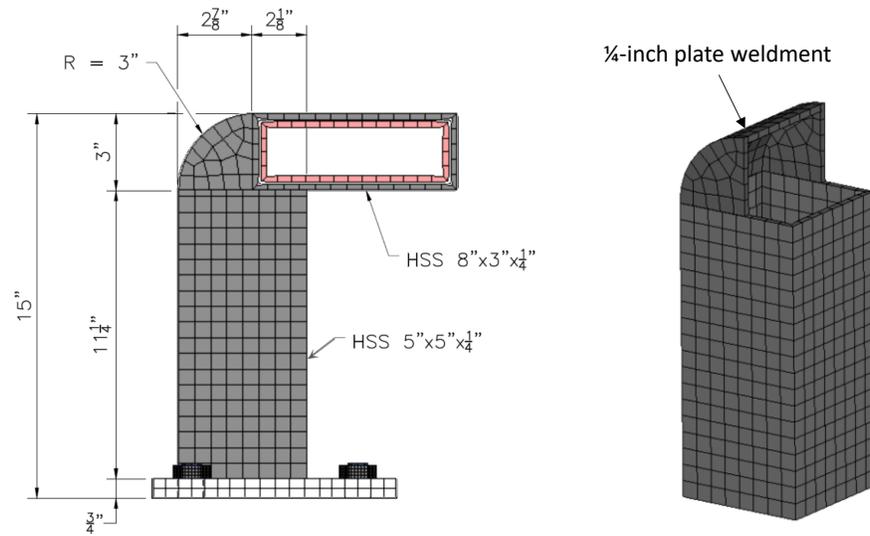
**Figure 10. FEA mesh of steel bridge rail post.**

The geometry of the posts was modeled according to the detailed drawings in Appendix A. The FEA model of the post is shown in Figure 10. The material for the HSS portion of the post model conformed to ASTM A500 Grade C; the material for the top weldment portion of the post conformed to ASTM A709 Grade 50 steel. The post was modeled with thin-shell Belytschko-Tsay elements (Type 2 in LS-DYNA) with five (5) integration points through the thickness. The mesh size was modeled with a nominal element size of 5/8” x 5/8”. The weldment was modeled as \*Constrained\_Spotwelds in LS-DYNA with no failure.

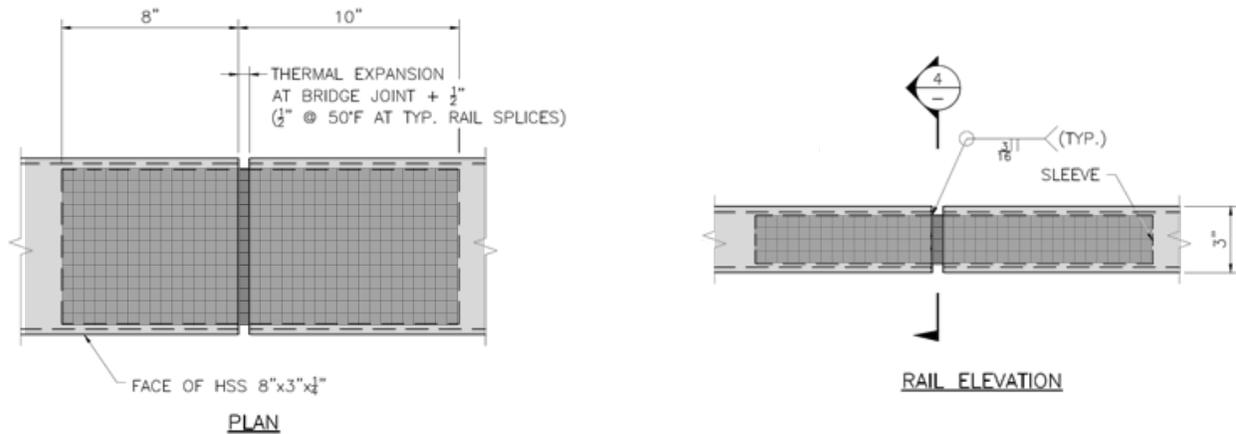
**Figure 12. Model of rail splice with rail-tube shown transparent.**

the adjoining main-rail sections was included according to the splice design. The modeled splice connection is shown in Figure 12. The splice tubes were modeled with the same material properties and mesh details as the main rail tubes.

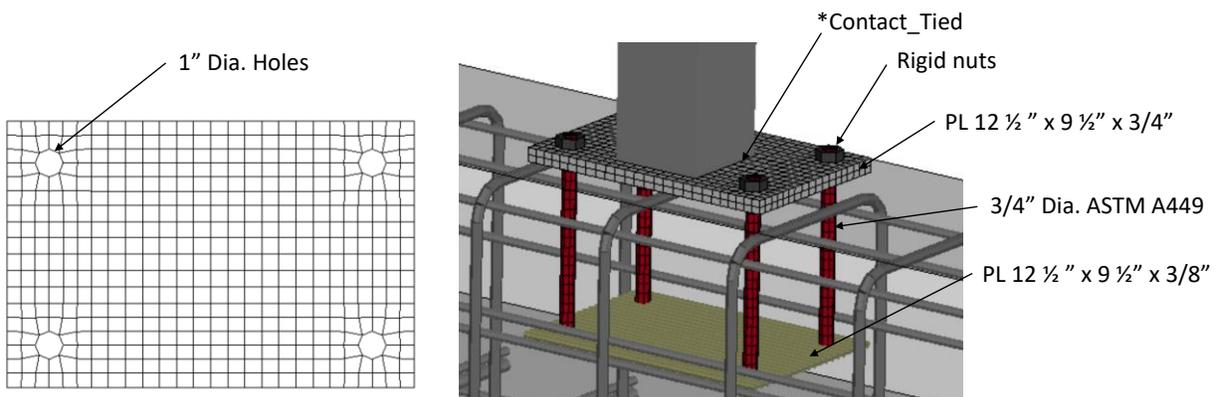
**Figure 13. Transparent view of concrete showing model of base plate and anchor bolts.**

The base plate was modeled with dimensions  $12\frac{1}{2}'' \times 9\frac{1}{2}'' \times \frac{3}{4}''$  and with material properties conforming to ASTM A709 Grade 50. The part was meshed with Type 3 hexahedral element (fully integrated quadratic 8 node element with nodal rotations) with nominal side length of  $\frac{9}{16}''$ . The welded connection of the post to the base plated was modeled using \*Contact\_Tied option in LS-DYNA. The  $\frac{3}{4}$ -inch diameter anchor bolts were modeled with Type 1 beam elements in LS-DYNA. The material for the anchor bolts conformed to ASTM A449, which has a minimum yield strength of 105 ksi, ultimate strength of 125 ksi, and 15 percent elongation. The nuts were modeled as rigid. The anchor bolts extended into the rigid deck, as illustrated in Figure 13. The bolts were anchored inside the deck using the \*Constrained\_Beam\_in\_Solid option in LS-DYNA. Null beams were added to the anchor plate so that its constraint to the curb/deck could also be modeled using \*Constrained\_Beam-in-Solid.

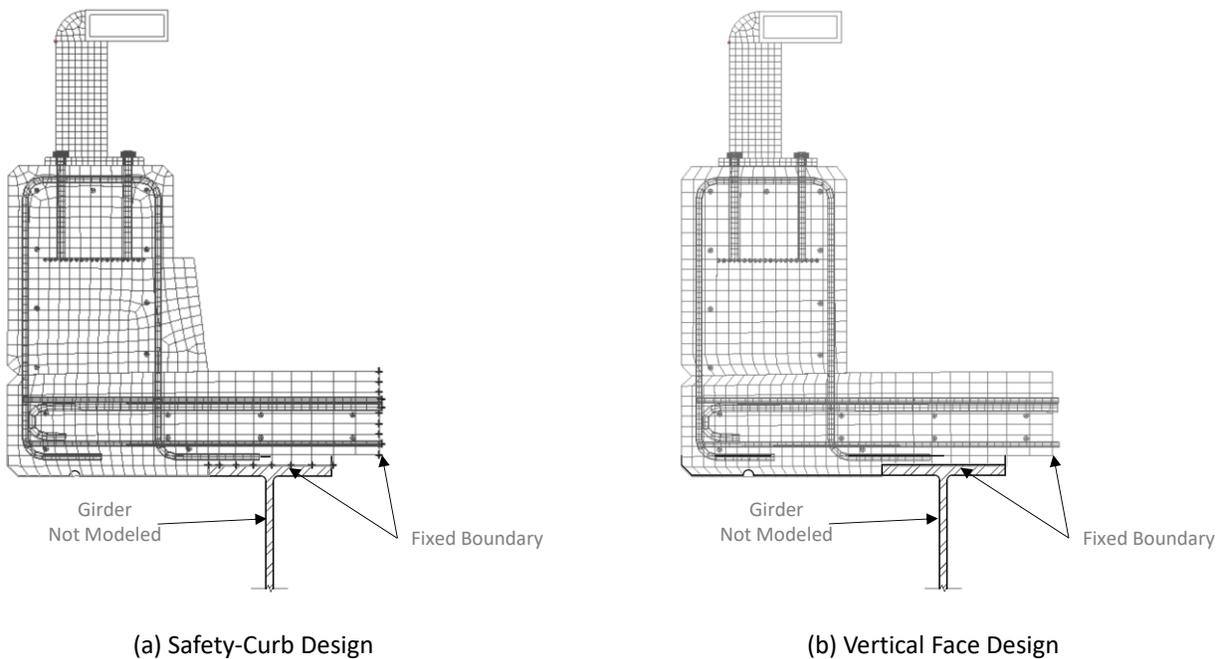
**Figure 14. FEA model details for the CM-MTL3 for (a) safety-curb design and (b) vertical face design.**

Fixed constraints were imposed on the boundary ends of deck rebar and on the boundary face of the concrete, as indicated in Figure 14 by "+" symbols. The roadway was model as rigid using the *\*Rigidwall\_Planar\_Finite* option in LS-DYNA.

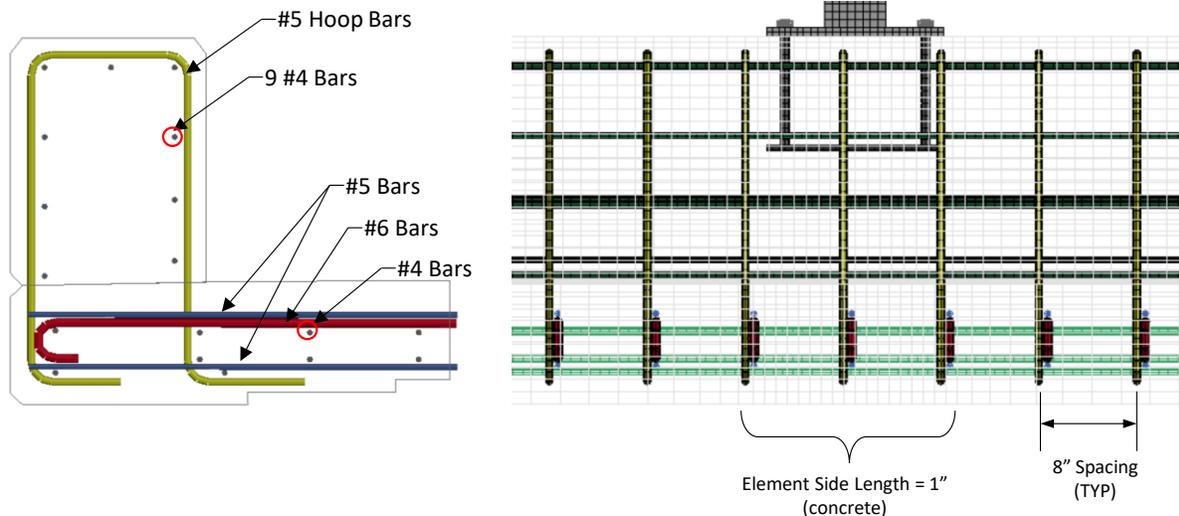
**Figure 15. FEA model details for concrete barrier and deck reinforcement.**

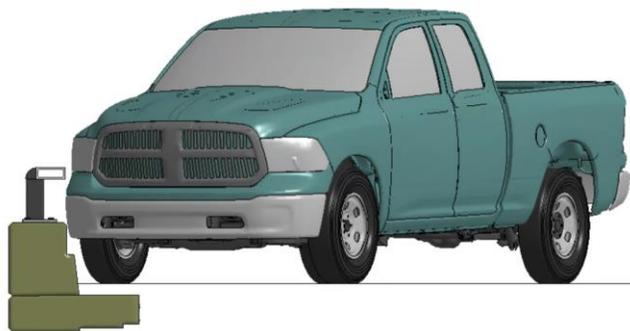
**Figure 16. FEA model of Test 3-11 on CM-MTL3 with safety curb.**

FEA was used to evaluate the crash performance of the CM-MTL3 bridge rail with integral safety-curb, as illustrated in Figure 16. The evaluations were based on structural adequacy, vehicle stability during and after redirection, and occupant risk factors using criteria specified in *MASH* for Test Level 3. Simulation of Test 3-11 included the 2270P Dodge Ram model ballasted to 5,182 lb (2,351 kg) impacting the railing at 63.7 mph and 25 degrees. The RHT concrete model in LS-DYNA was used for these analyses with parameters as described in Chapter 4. The analysis in all cases was performed using LS-DYNA version mpp\_s\_R10.2.0 revision number 135267. The analysis was conducted with a time-step of 1.0 microsecond for a period of 0.735 second of the impact event.

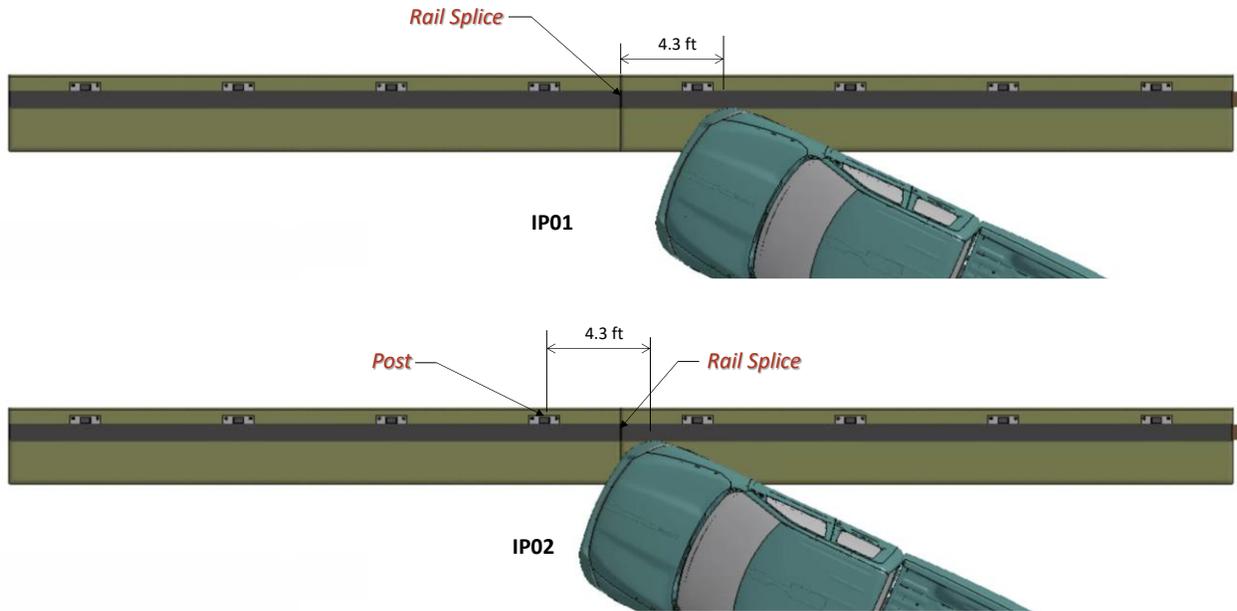
**Figure 17. Critical impact point evaluated.**

The 5,182-lb pickup model struck the barrier at 4.3 feet upstream of the rail splice connection for IP01 and 4.3 feet upstream of the critical post for IP02. The impact speed was 63.7 mph, and the impact angle was 25 degrees. The sequential views of the impact event are shown in Appendices B and C for IP01 and IP02, respectively. Additional details for the sequence of key events for this analysis case are provided in Table 5. The following sections provide time-history data evaluation, occupant risk assessments, and damages sustained by both the barrier and vehicle for these two impact cases.

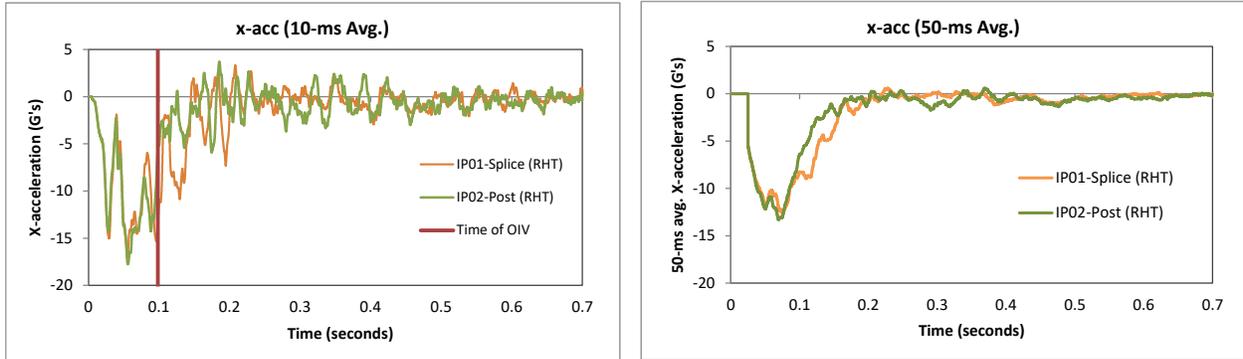
**Figure 18. 10- and 50-millisecond average X-acceleration from FEA of Test 3-11 on the CM-MTL3 with safety curb at IP01 and IP02.**

Figures 18 through 20 show the longitudinal, transverse, and vertical acceleration-time histories, respectively, computed from the center of gravity of the vehicle; Figures 21 through 23 show the comparison of the angular rates and angular displacement about the x-, y-, and z-axis at the center of gravity of the vehicle.

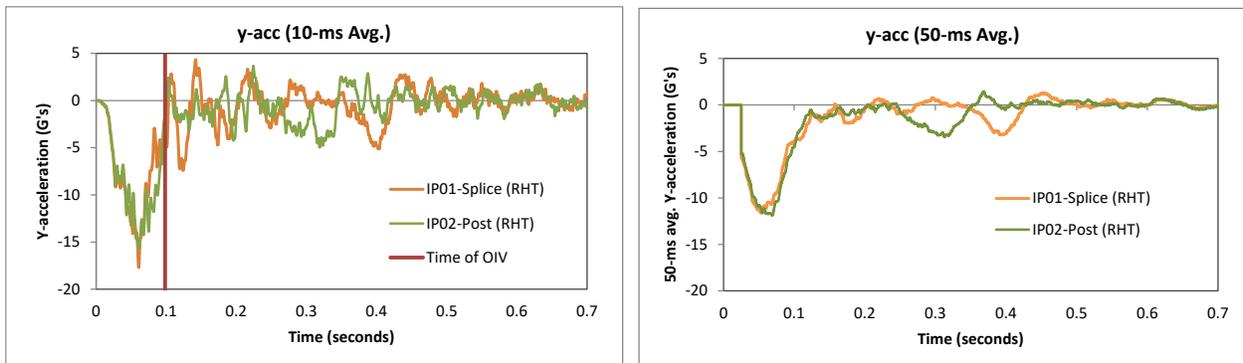
**Figure 19. 10- and 50-millisecond average Y-acceleration from FEA of Test 3-11 on the CM-MTL3 with safety curb at IP01 and IP02.**

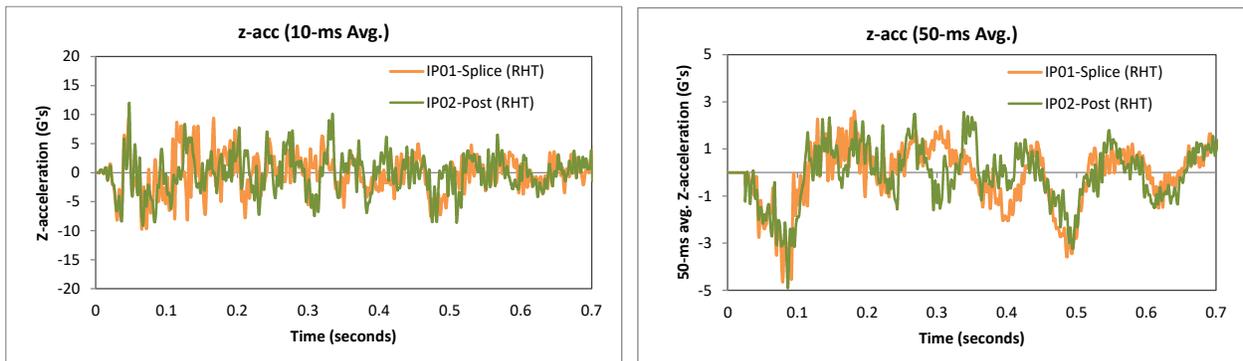
**Figure 20. 10- and 50-millisecond average Z-acceleration from FEA of Test 3-11 on the CM-MTL3 with safety curb at IP01 and IP02.**

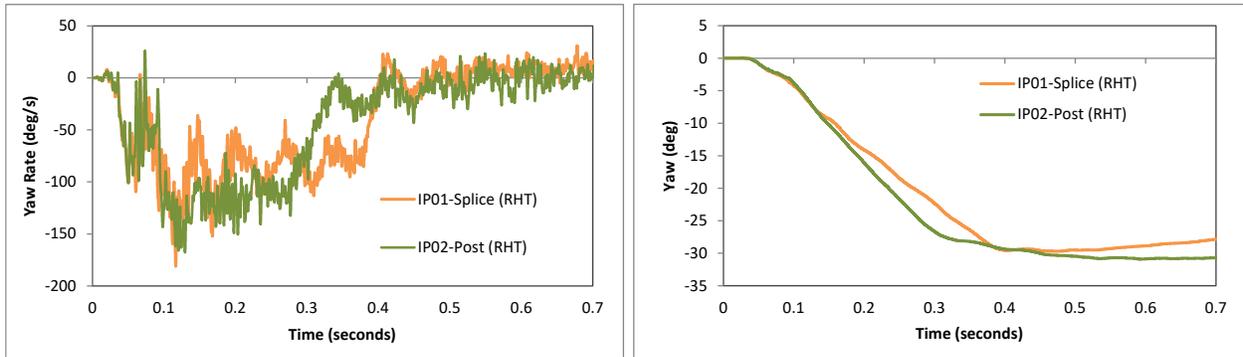
**Figure 21. Yaw rate and yaw angle time-history from FEA of Test 3-11 on the CM-MTL3 with safety curb at IP01 and IP02.**

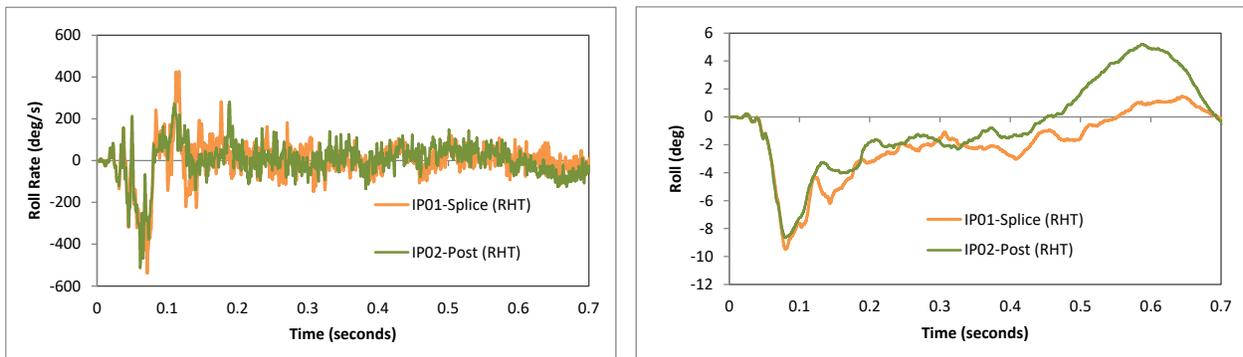
**Figure 22. Roll rate and roll angle time-history from FEA of Test 3-11 on the CM-MTL3 with safety curb at IP01 and IP02.**

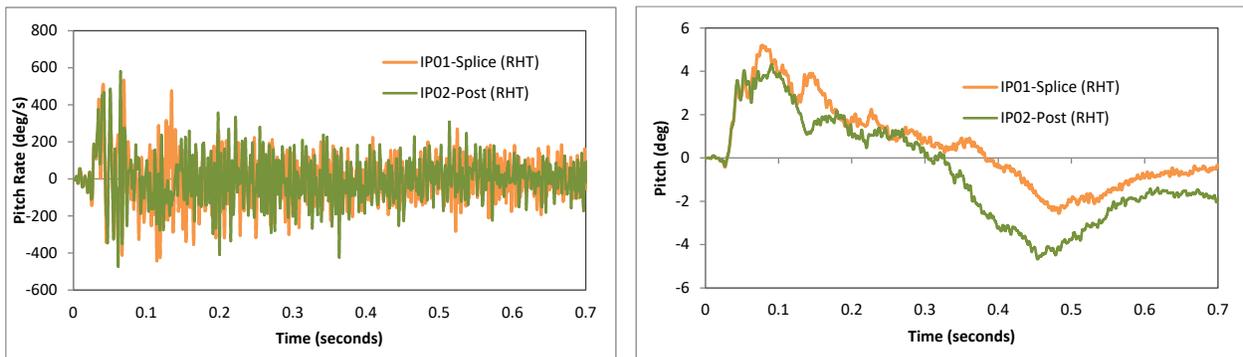
**Figure 23. Pitch rate and pitch angle time-history from FEA of Test 3-11 on the CM-MTL3 with safety curb at IP01 and IP02.**

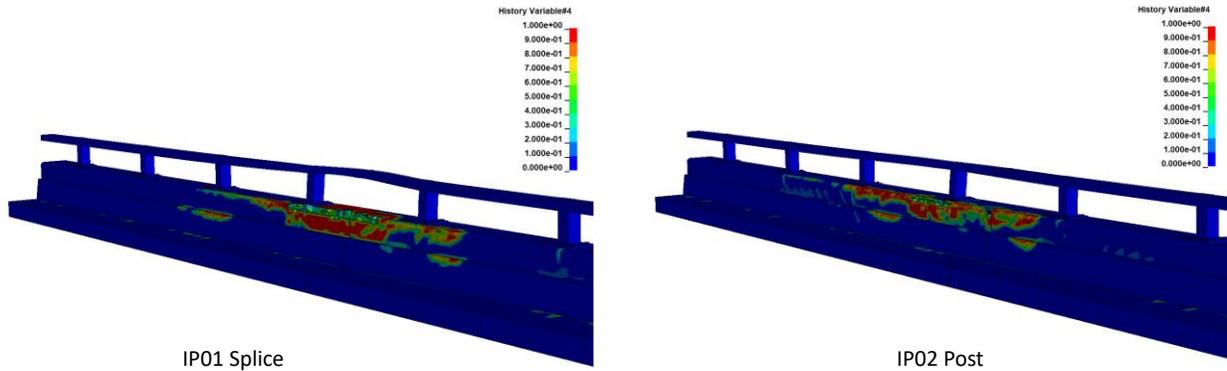
**Figure 25. Contour plot of the damage variable for Test 3-11 on the curbed CM-MTL3 for IP01 and IP02.**

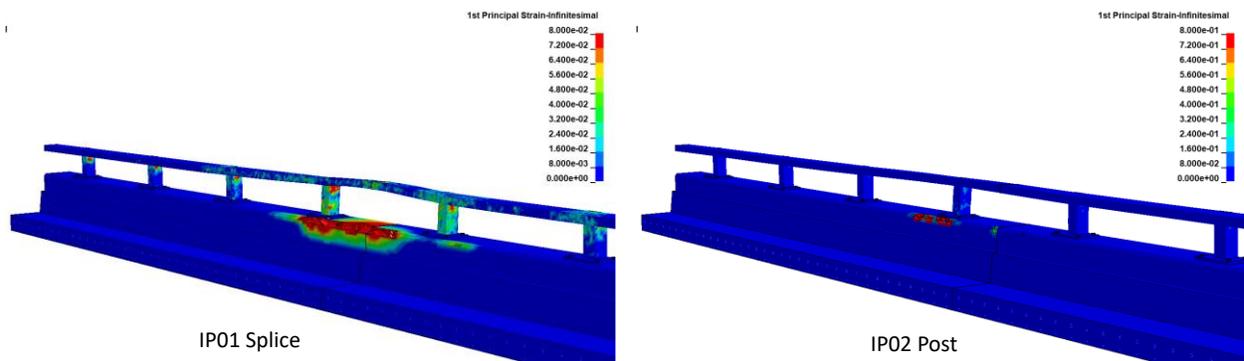
**Figure 26. Contour plot of the 1<sup>st</sup> principal strain for Test 3-11 on the curbed CM-MTL3 for IP01 and IP02.**

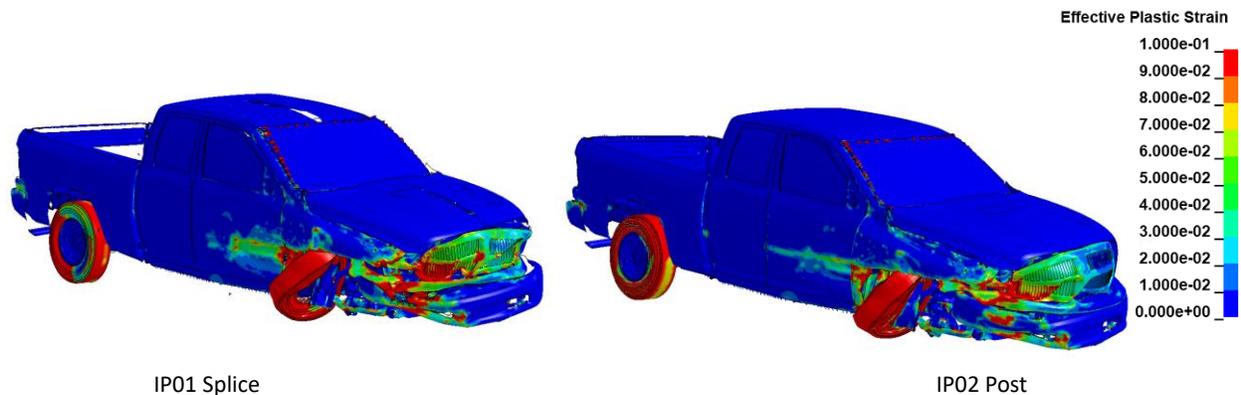
**Figure 27. Damages to vehicle in Test 3-11 analysis of curbed CM-MTL3 for IP01 and IP02.**

Figure 27 shows contour plots of effective plastic strain for the vehicle, which were used to identify areas of the vehicle that suffered damage during the simulated impact event. Damage to the vehicle was limited to the impact side of the front cap, the front impact-side wheel assembly, impact-side doors, and rear section of pickup bed.

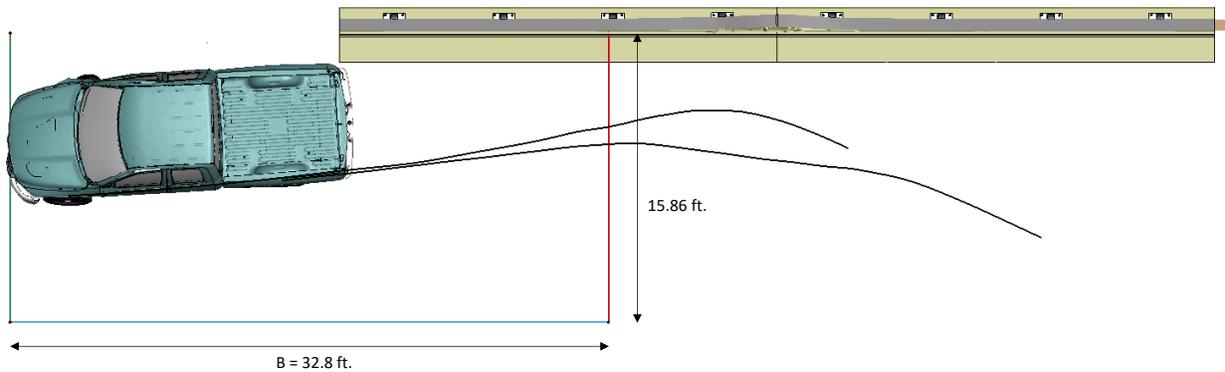
**Figure 29. Exit box for Test 3-11 on the curbed CM-MTL3 for IP01.**

Figures 29 and 30 show the exit box for Test 3-11 on the curbed CM-MTL3 for cases IP01 and IP02, respectively. Although the exit box analysis is not required in *MASH*, it was included here for completeness. The vehicle was redirected with its path well within the exit box criteria of *MASH* for both analysis cases.

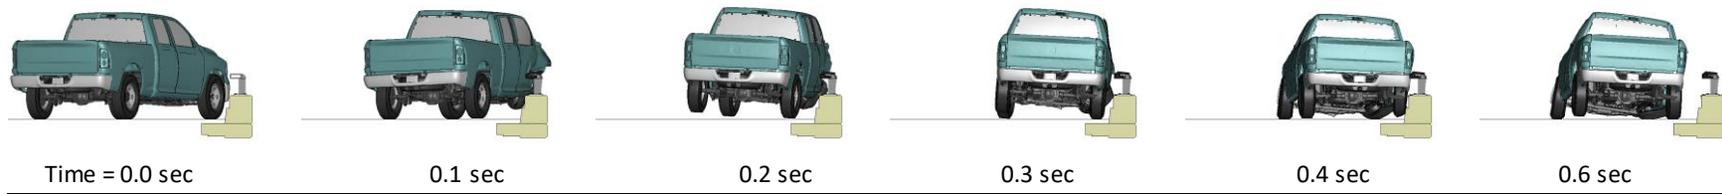
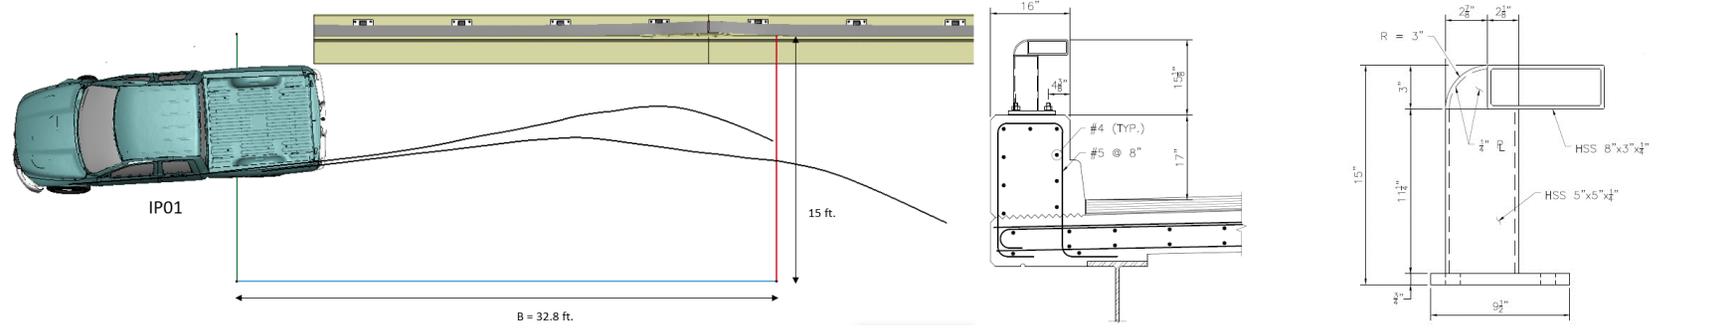
General Information		Impact Conditions		Max50-millisecond Avg. (G)	
Analysis Agency .....	Roadsafe LLC	Speed .....	63.7 mph	Longitudinal .....	12.7 g
Test Standard Test No. ....	MASH Test 3-11	Angle .....	25 degrees	Lateral .....	11.6 g
Analysis No. ....	CM-TL3 D1 IP01-Splice	Location .....	4.3 ft upstream of critical splice	Vertical .....	4.6 g
Analysis Date .....	7/19/2021				
Test Article		Impact Severity .....		Test Article Deflections (in)	
Type .....	Bridge Rail	121.1 kip-ft		Dynamic .....	3.1 inches
Name .....	CM-TL3	Exit Conditions		Permanent .....	2.6 inches
Installation Length .....	48.0 feet	Speed .....	34.2 mph	Working Width .....	16.0 inches
Material or Key Elements .....	Continuous concrete with top mounted steel post-and-beam rail	Angle .....	4.7 degrees		
Soil Type and Condition .....	NA	Time .....	0.46 seconds	Max. OCI .....

Figure 31. Summary results for MASH Test 3-11 on the CM-MTL3 bridge rail with integral safety curb.

A summary of the *MASH* Test 3-11 results on the curbed CM-MTL3 bridge rail is shown in Table 8 and Figures 31 and 32. The barrier successfully contained and redirected the pickup with moderate damage to the bridge rail. There were no detached elements from the barrier that showed potential for penetrating into the occupant compartment or presenting undue hazard to other traffic. The vehicle remained upright and did not experience excessive roll or pitch angle displacements. The OIV and maximum ORA values were within preferred limits specified in *MASH*. Based on the results of this analysis, the barrier is expected to meet all structural and occupant risk criteria in *MASH* for Test 3-11 impact conditions.

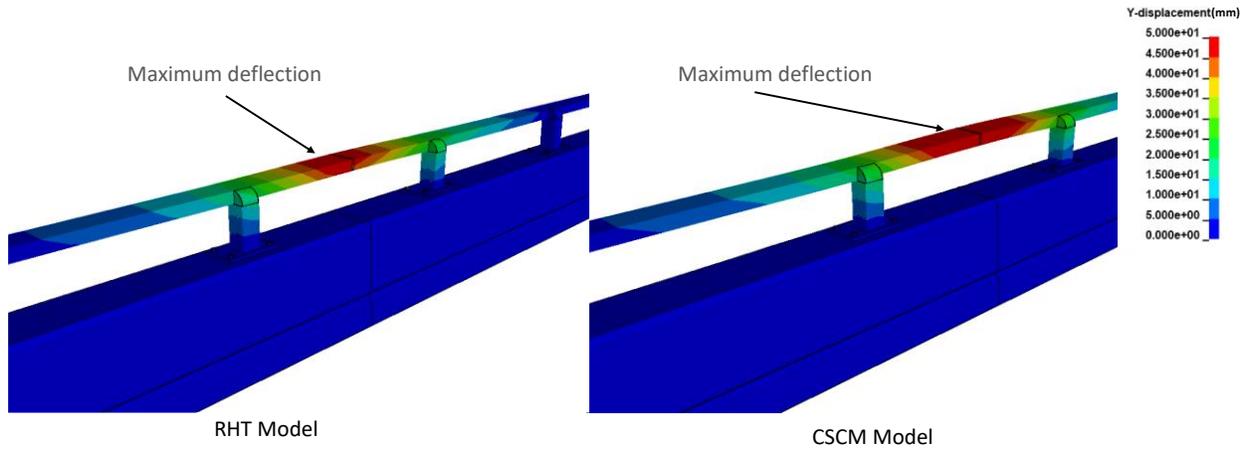
Maximum dynamic deflection = 2.4 in (61.9 mm) @ 0.11 sec  
 Maximum permanent deflection = 2.0 in (50.6 mm)

**Figure 39. Contour plot of lateral displacement for Test 3-11 at IP01 on CM-MTL3 with vertical face.**

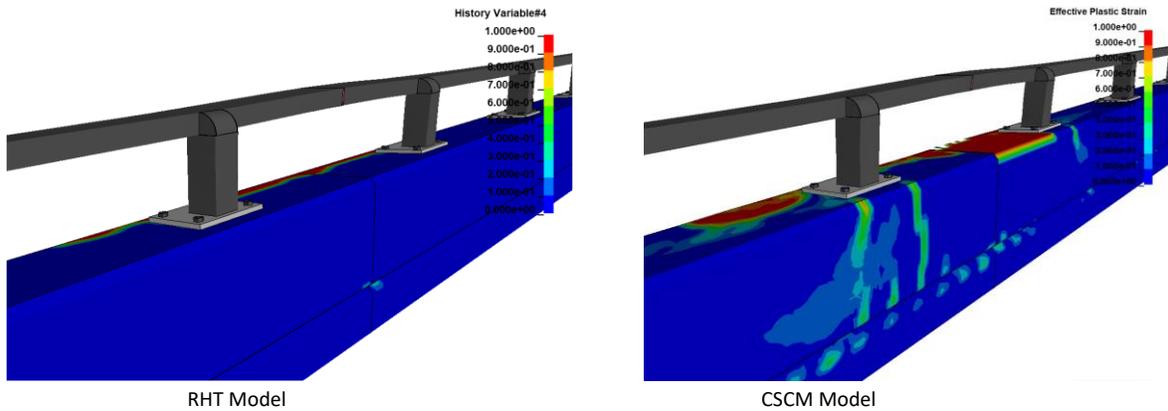
**Figure 40. Contour plot of the damage variable for Test 3-11 at IP01 on CM-MTL3 with vertical face.**

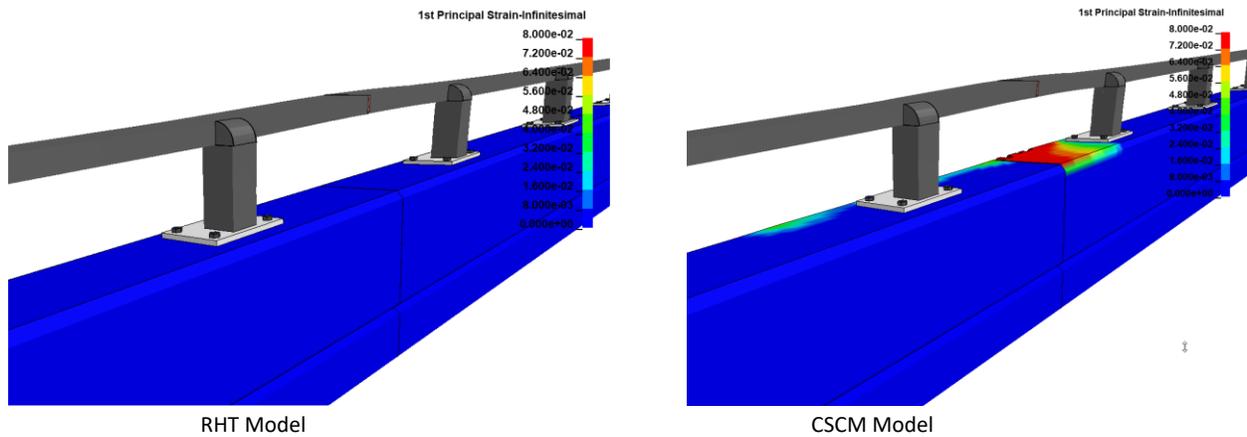
**Figure 41. Contour plot of the 1<sup>st</sup> principal strain for Test 3-11 at IP01 on CM-MTL3 with vertical face.**

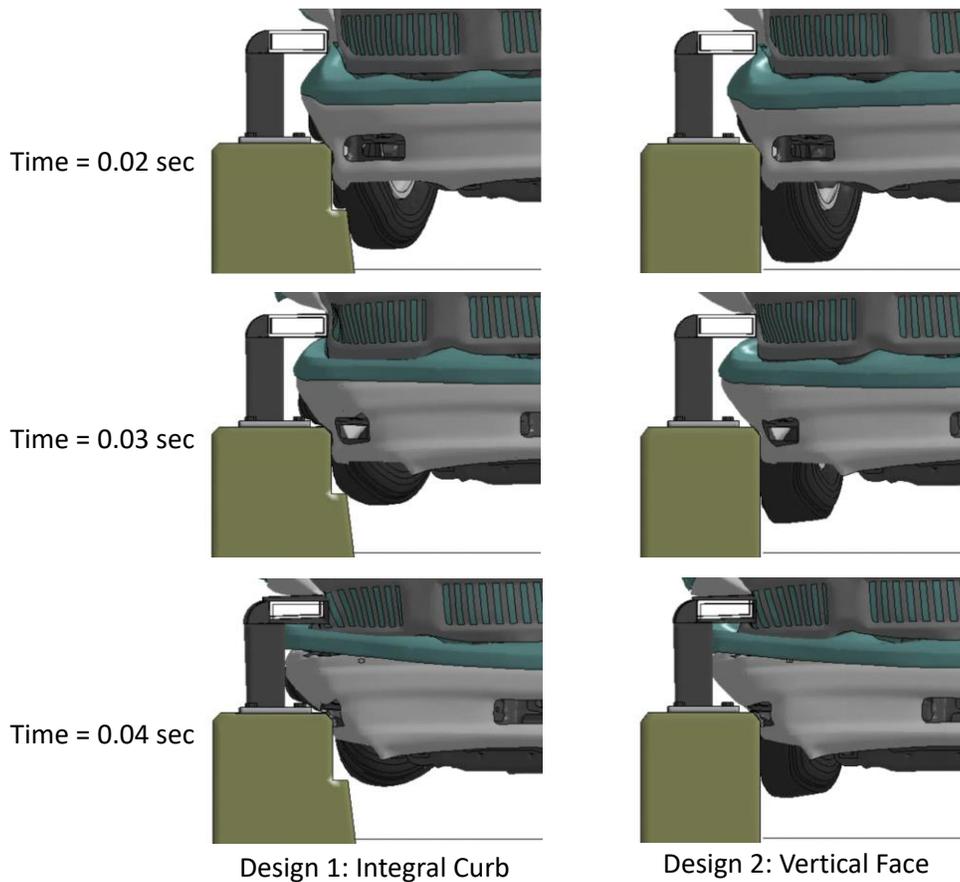
**Figure 42. Comparison of wheel response from Test 3-11 impact at IP01 for the CM-MTL3 with and without the integral curb.**

The damage to the face of the barrier was significantly reduced compared to the results from the analysis of the CM-MTL3 with integral curb. As shown in Figure 42, the wheel climbed the barrier in both cases; however, the case involving the integral curb resulted in abrupt tire-steer toward the barrier causing significant spalling along the top edge of the barrier; this did not occur for the CM-MTL3 with vertical face.

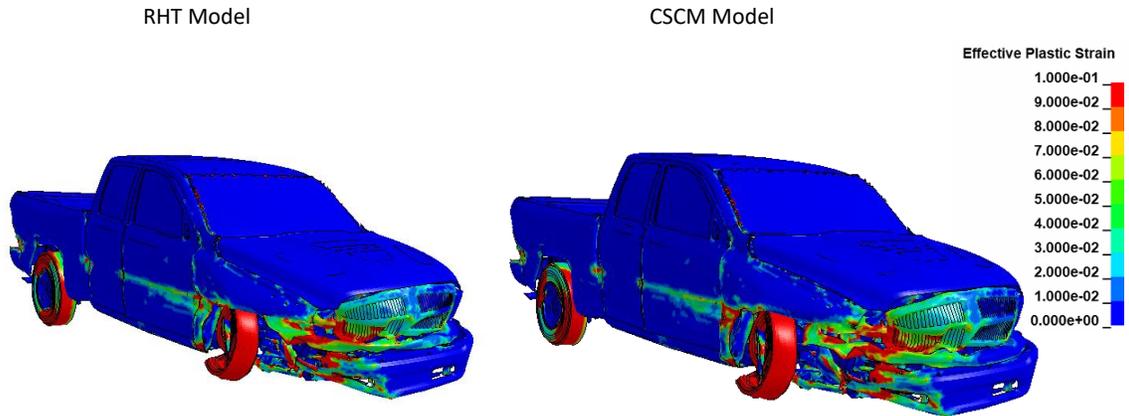
**Figure 43. Damages to vehicle in Test 3-11 at IP01 on CM-MTL3 with vertical face.**

Figure 43 shows contour plots of effective plastic strain for the vehicle, which were used to identify areas of the vehicle that suffered damage during the simulated impact event. Damage to the vehicle was limited to the impact side of the front cap, the front impact-side wheel assembly, impact-side doors, front edge of pickup bed, and rear section of pickup bed.

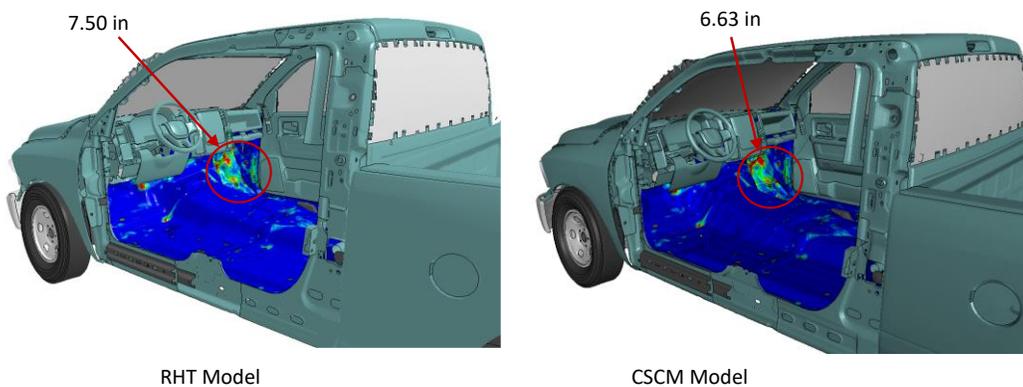
**Figure 44. Occupant compartment deformation resulting from Test 3-11 at IP01 on CM-MTL3 with vertical face.**

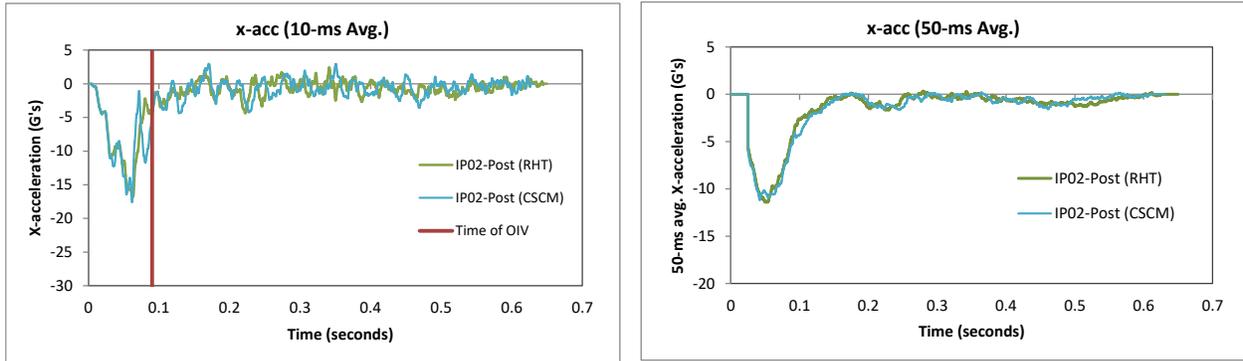
**Figure 48. 10- and 50-millisecond average X-acceleration from FEA of Test 3-11 at IP02 on CM-MTL3 with vertical face.**

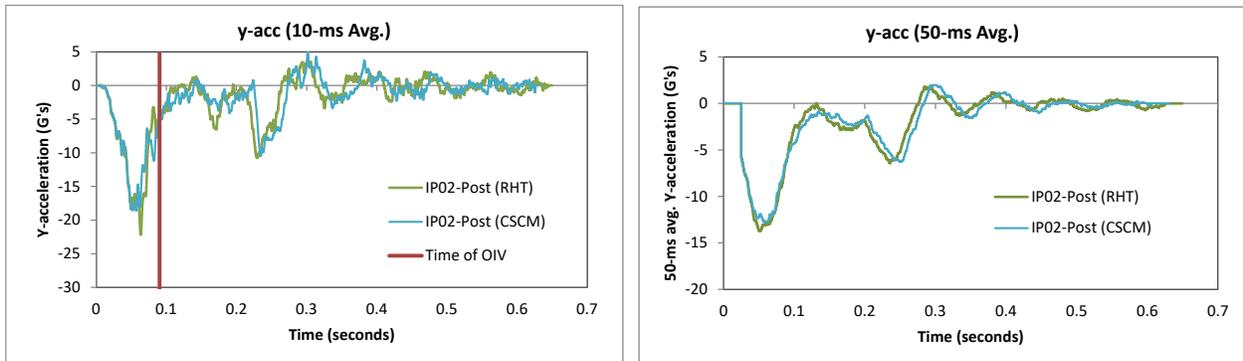
**Figure 49. 10- and 50-millisecond average Y-acceleration from FEA of Test 3-11 at IP02 on CM-MTL3 with vertical face.**

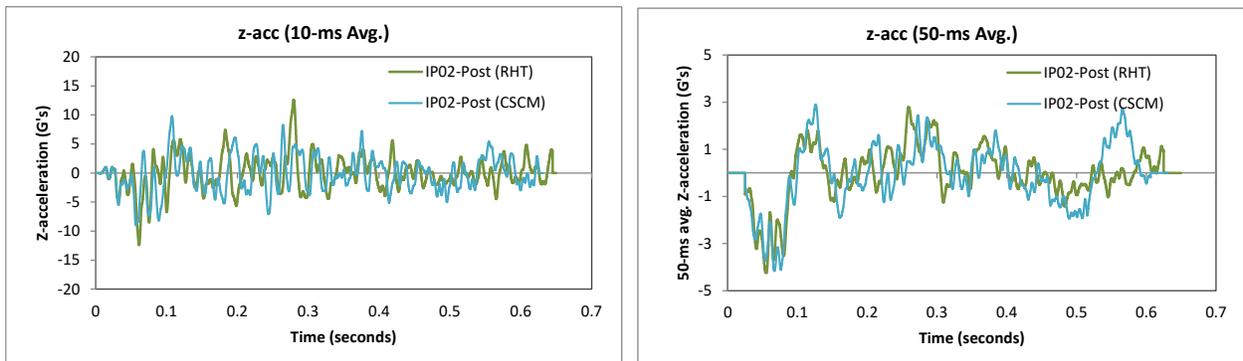
**Figure 50. 10- and 50-millisecond average Z-acceleration from FEA of Test 3-11 at IP02 on CM-MTL3 with vertical face.**

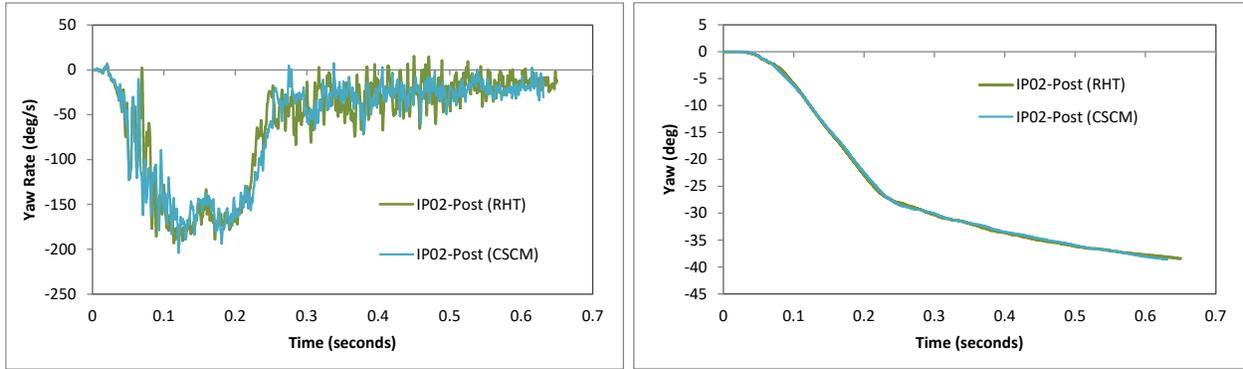
**Figure 51. Yaw rate and yaw angle time-history from FEA of Test 3-11 at IP02 on CM-MTL3 with vertical face.**

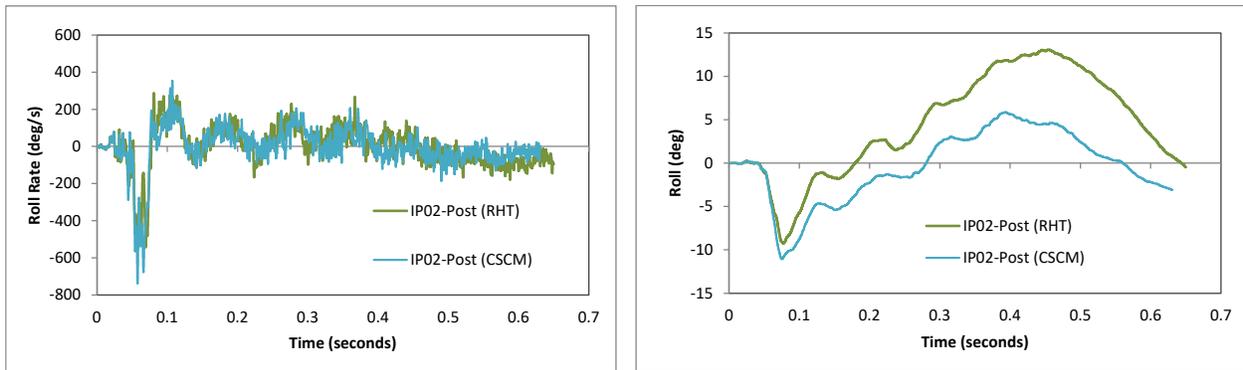
**Figure 52. Roll rate and roll angle time-history from FEA of Test 3-11 at IP02 on CM-MTL3 with vertical face.**

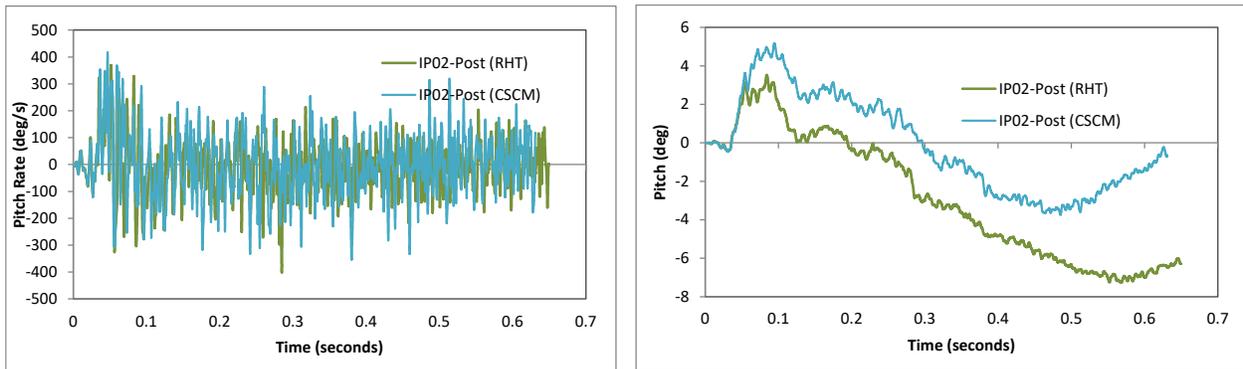
**Figure 53. Pitch rate and pitch angle time-history from FEA of Test 3-11 at IP02 on CM-MTL3 with vertical face.**

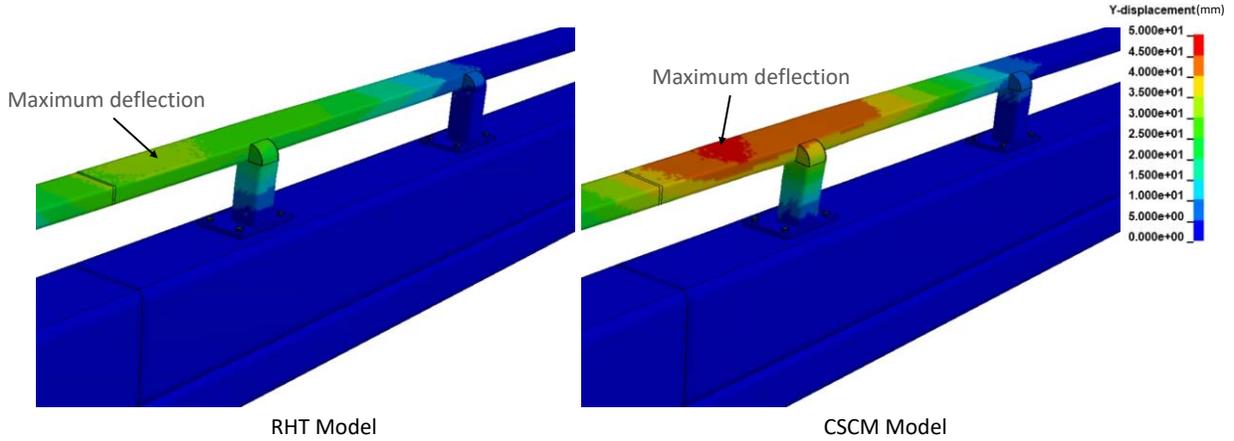
**Figure 54. Contour plot of lateral displacement for Test 3-11 at IP02 on CM-MTL3 with vertical face.**

Figure 54 shows images of maximum permanent deflection of the barrier with a contour plot of lateral displacement on the bridge rail. The dynamic deflection was 1.6 inches and 2.2 inches for the RHT and CSCM models, respectively. For both cases, the maximum deflection occurred at 0.23 seconds during the tail-slap of the vehicle with the barrier. The maximum permanent dynamic deflection was 1.2 inches and 1.8 inches for the RHT and CSCM case, respectively. Figure 55 shows contour plots of the damage parameter computed in LS-DYNA, and Figure 56 shows contour plots of the 1<sup>st</sup> principal strain. Similar to the previous analysis case, both models indicated spalling on the front face of barrier, while the CSCM showed additional spalling across the top surface. The CSCM model indicated small crack formation radiating from back-side anchor bolts, while the RHT model showed little to no potential for such cracks.
