*MASH TL3 EVALUATION OF  
MASSDOT'S CM-MTL3 BRIDGE RAIL  
USING FINITE ELEMENT ANALYSIS*

Prepared for: **Gill Engineering and the Massachusetts Department of  
Transportation**

Project No: **X129053P11 - PHASE IV**

July 30, 2021

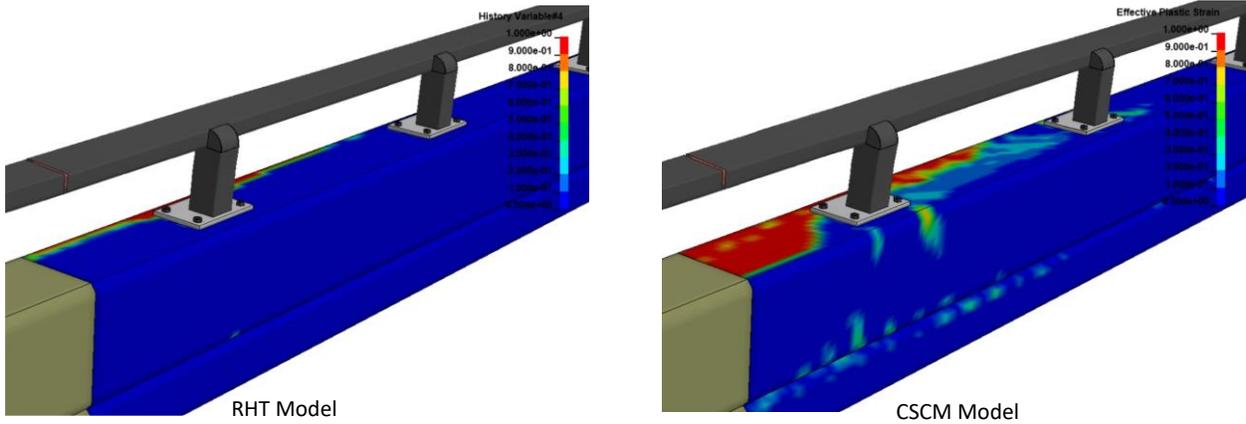
**Figure 55. Contour plot of the damage variable for Test 3-11 at IP02 on CM-MTL3 with vertical face.**

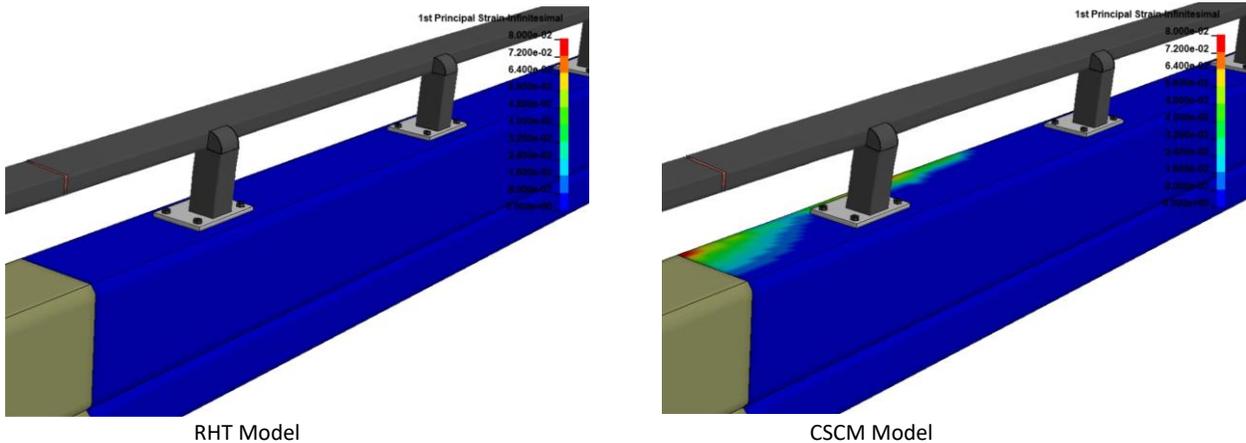
**Figure 56. Contour plot of the 1<sup>st</sup> principal strain for Test 3-11 at IP02 on CM-MTL3 with vertical face.**

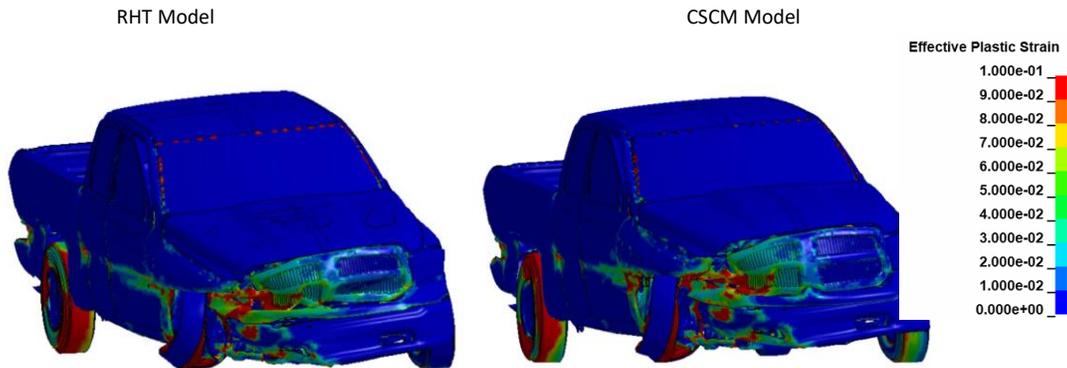
Figure 57. Damages to vehicle in Test 3-11 at IP02 on CM-MTL3 with vertical face.

Figure 57 shows contour plots of effective plastic strain for the vehicle, which were used to identify areas of the vehicle that suffered damage during the simulated impact event. Damage to the vehicle was limited to the impact side of the front cap, the front impact-side wheel assembly, impact-side doors, front edge of pickup bed, and rear section of pickup bed.

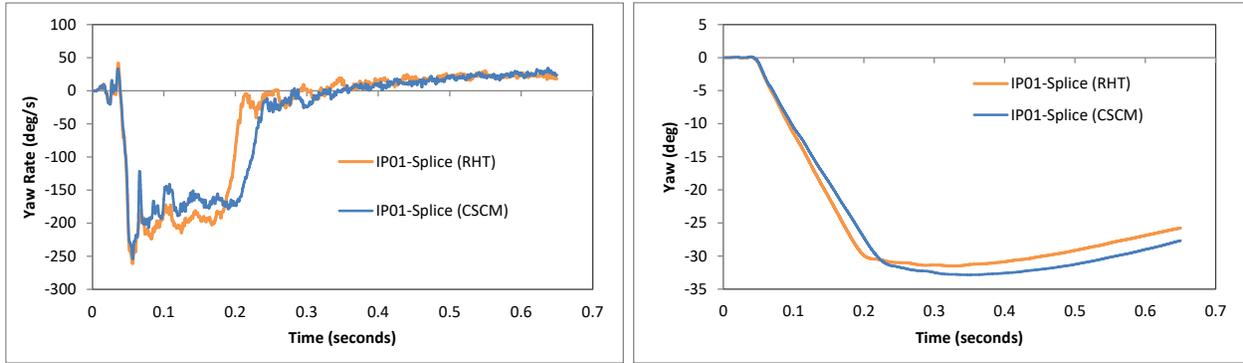
**Figure 65. Yaw rate and yaw angle time-history from FEA of Test 3-10 at IP01 on CM-MTL3 with vertical face.**

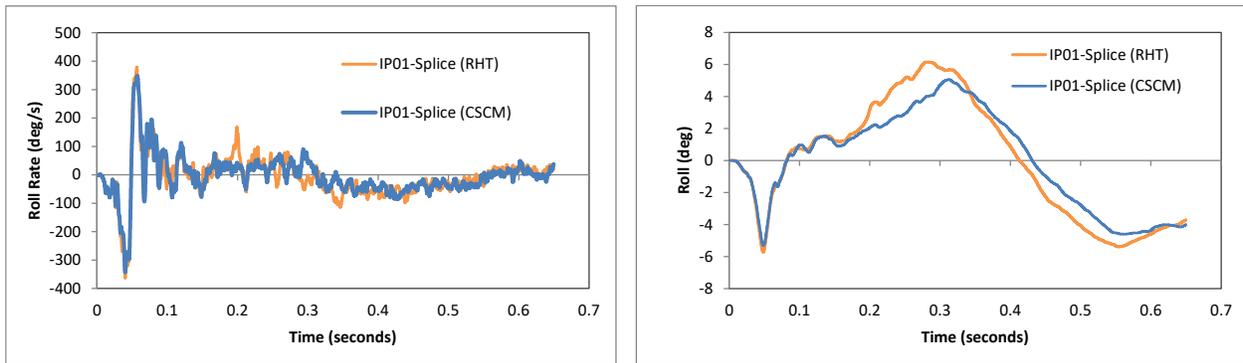
**Figure 66. Roll rate and roll angle time-history from FEA of Test 3-10 at IP01 on CM-MTL3 with vertical face.**

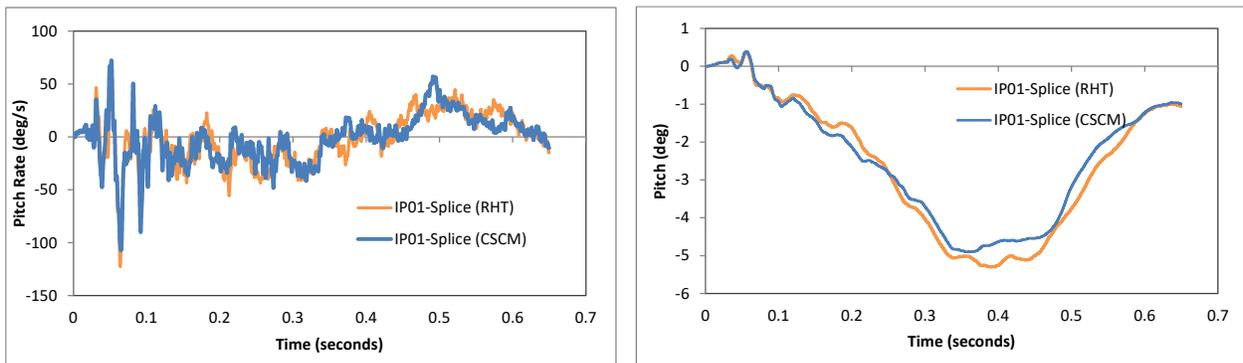
**Figure 67. Pitch rate and pitch angle time-history from FEA of Test 3-10 at IP01 on CM-MTL3 with vertical face.**

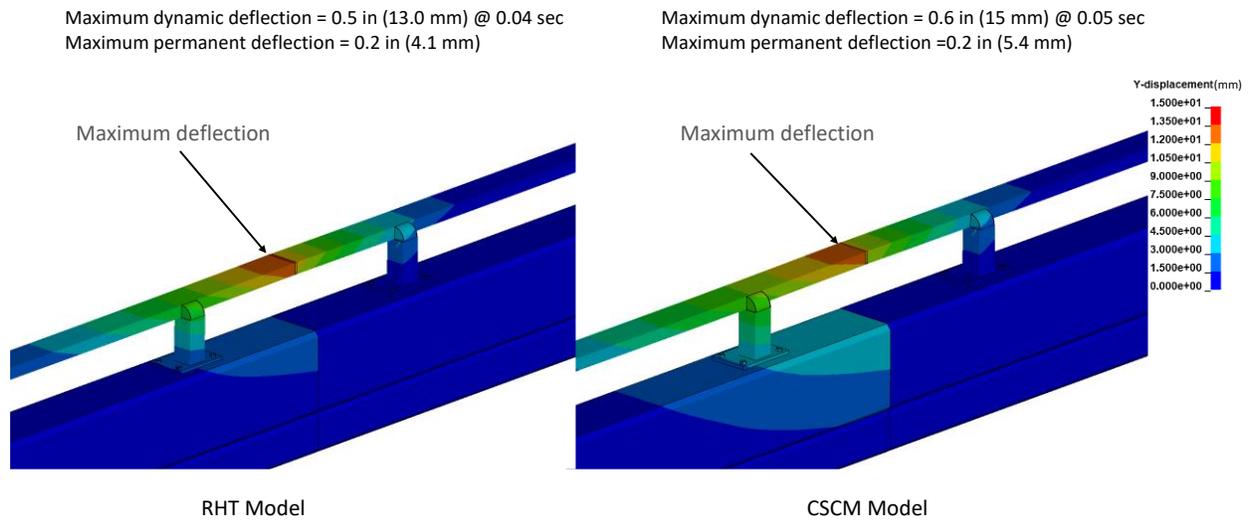
**Figure 68. Contour plot of lateral displacement for Test 3-10 at IP01 on CM-MTL3 with vertical face.**

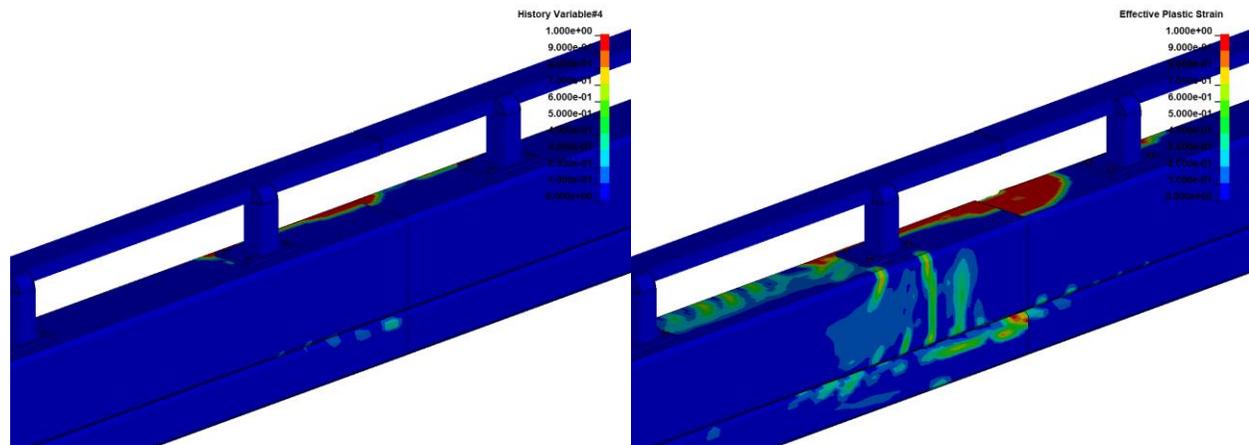
**Figure 69. Contour plot of the damage variable for Test 3-10 at IP01 on CM-MTL3 with vertical face.**

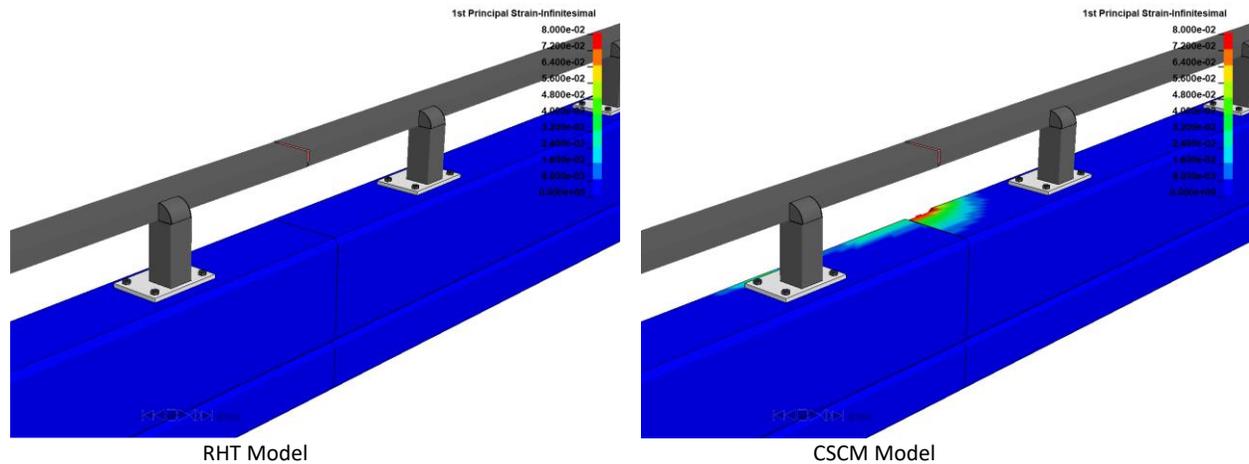
**Figure 70. Contour plot of the 1<sup>st</sup> principal strain for Test 3-10 at IP01 on CM-MTL3 with vertical face.**

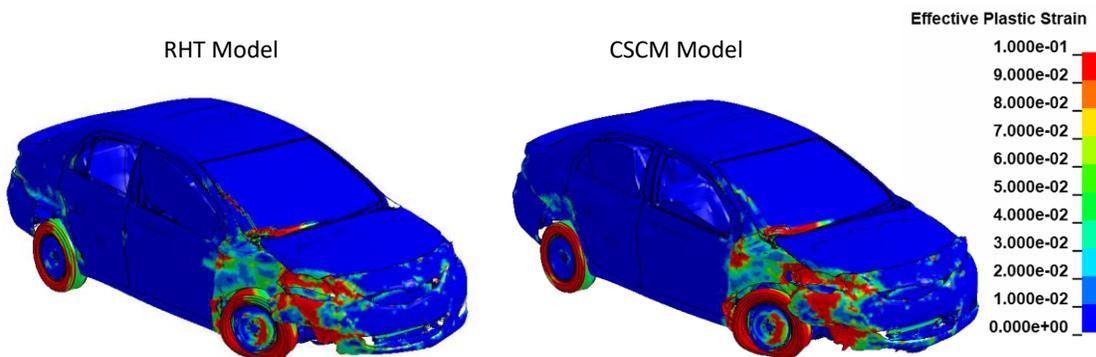
**Figure 71. Damages to vehicle in Test 3-10 at IP01 on CM-MTL3 with vertical face.**

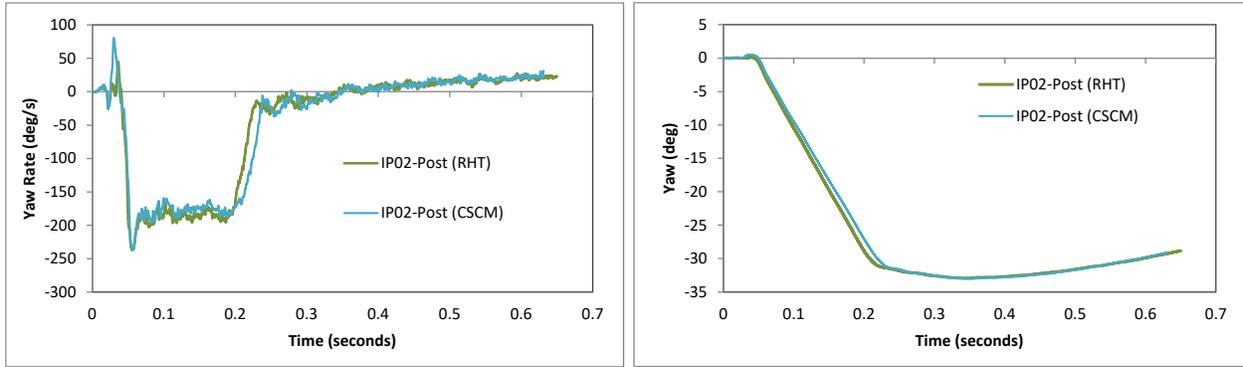
**Figure 79. Yaw rate and yaw angle time-history from FEA of Test 3-10 at IP02 on CM-MTL3 with vertical face.**

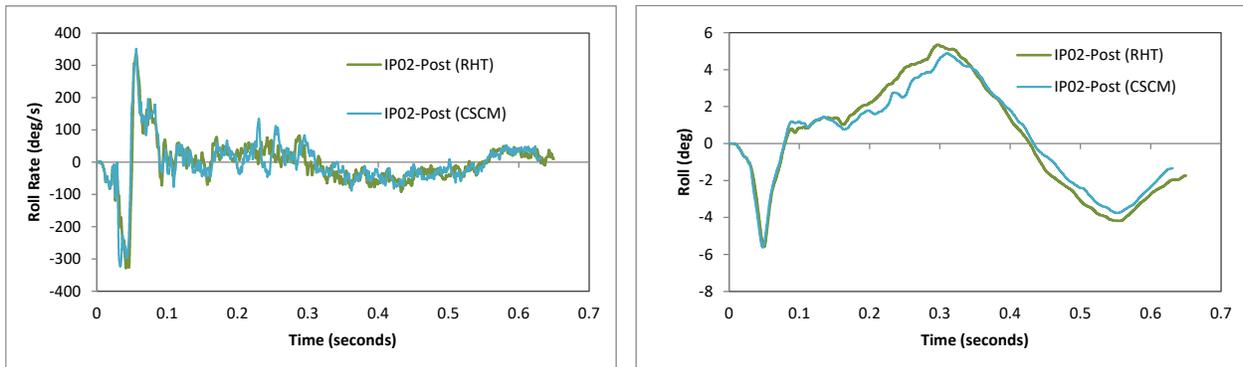
**Figure 80. Roll rate and roll angle time-history from FEA of Test 3-10 at IP02 on CM-MTL3 with vertical face.**

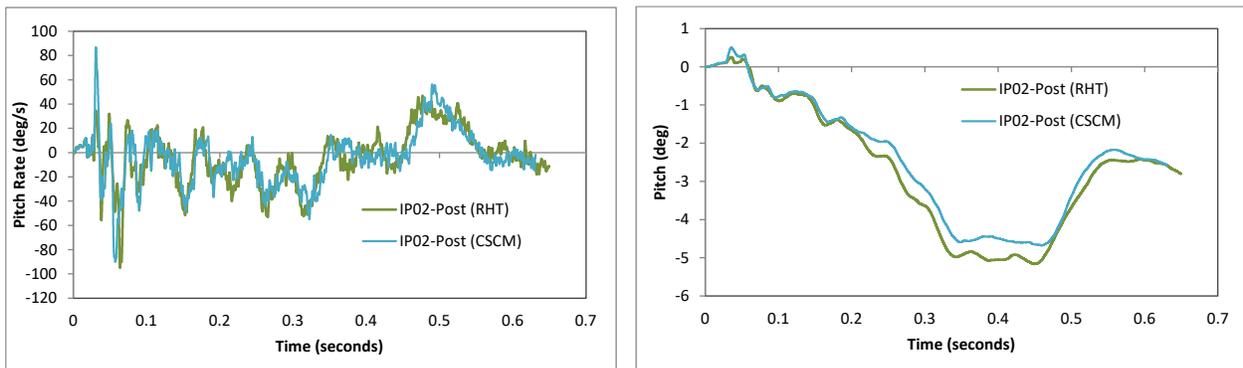
**Figure 81. Pitch rate and pitch angle time-history from FEA of Test 3-10 at IP02 on CM-MTL3 with vertical face.**

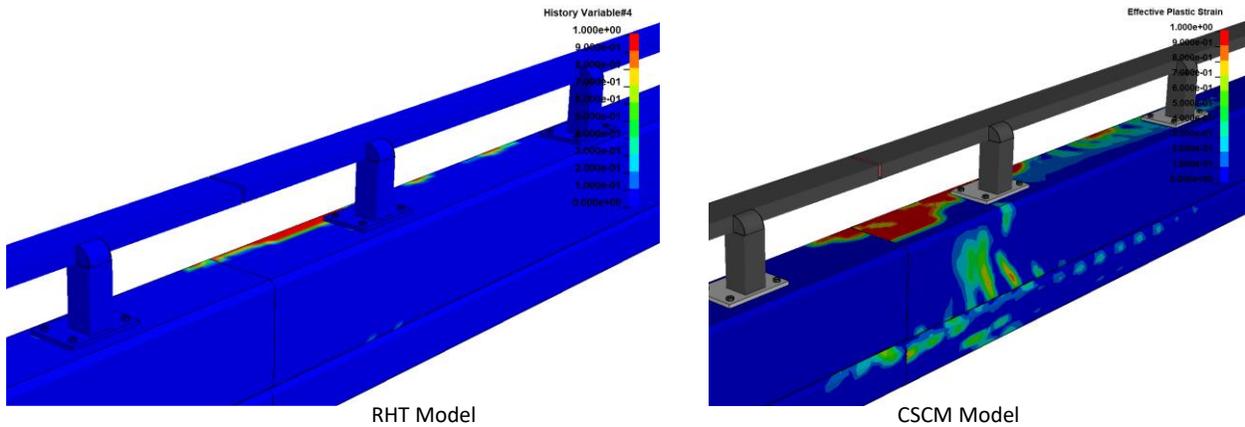
**Figure 82. Contour plot of lateral displacement for Test 3-10 at IP02 on CM-MTL3 with vertical face.**

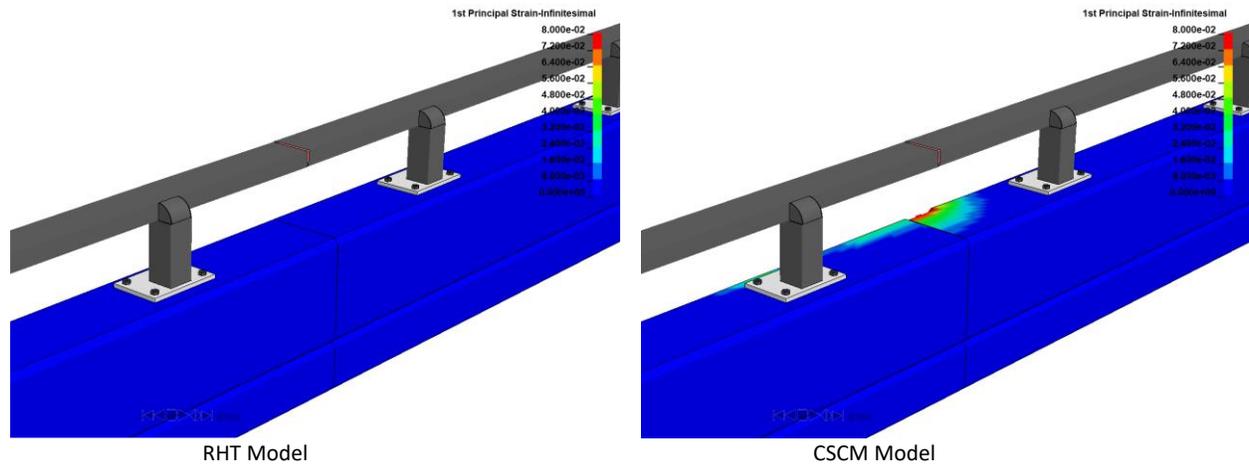
**Figure 84. Contour plot of the 1<sup>st</sup> principal strain for Test 3-10 at IP02 on CM-MTL3 with vertical face.**

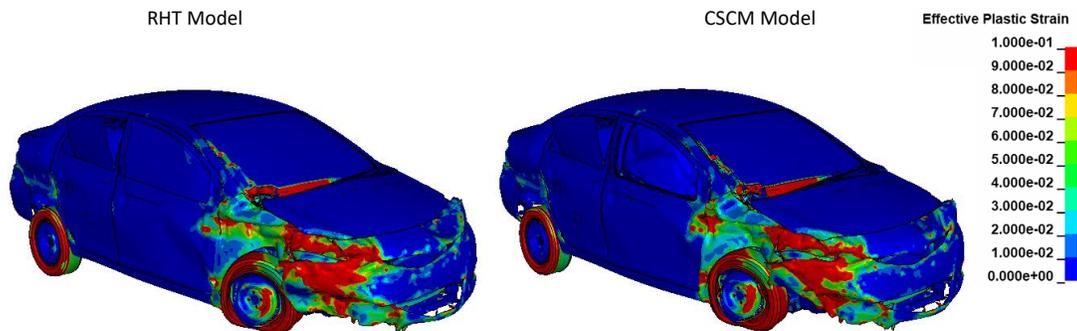
**Figure 85. Damages to vehicle in Test 3-10 at IP02 on CM-MTL3 with vertical face**

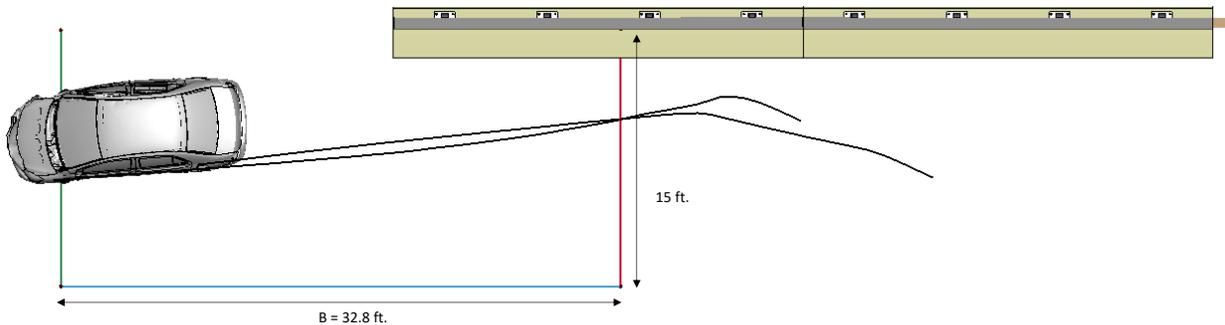
**Figure 87. Exit box for Test 3-10 at IP02 on CM-MTL3 with vertical face (RHT model).**

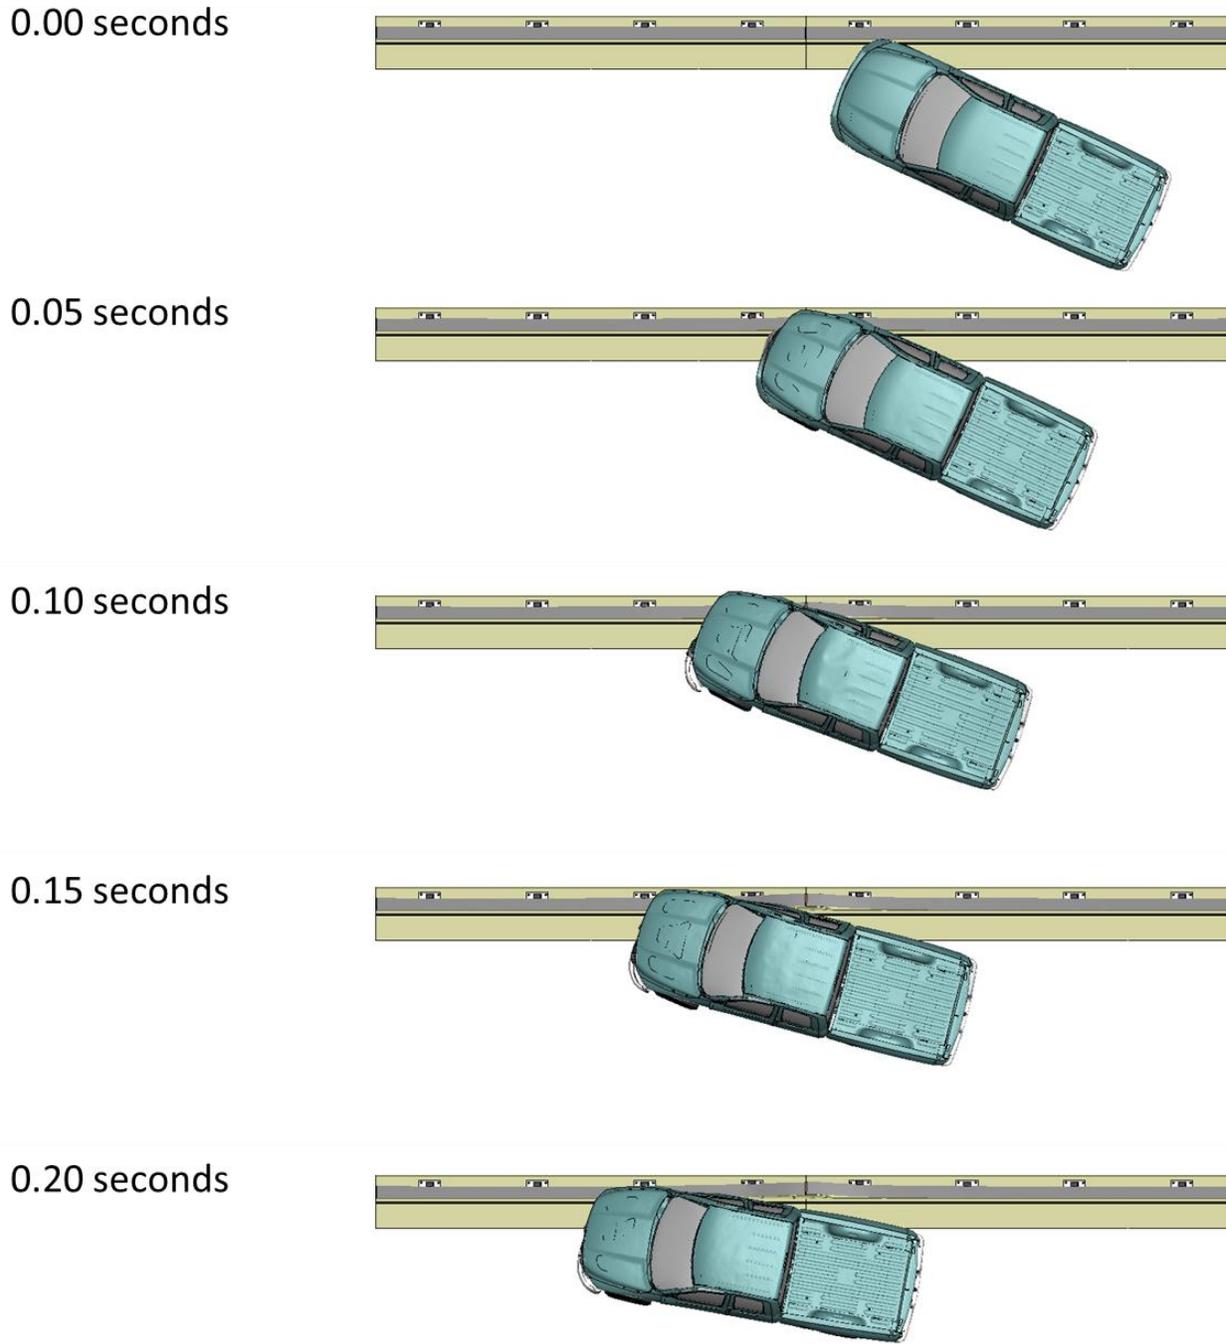
**Figure B-1. Sequential views from analysis of MASH Test 3-11 at IP01 on CM-MTL3 Bridge Rail with Safety-Curb Design from an overhead viewpoint.**

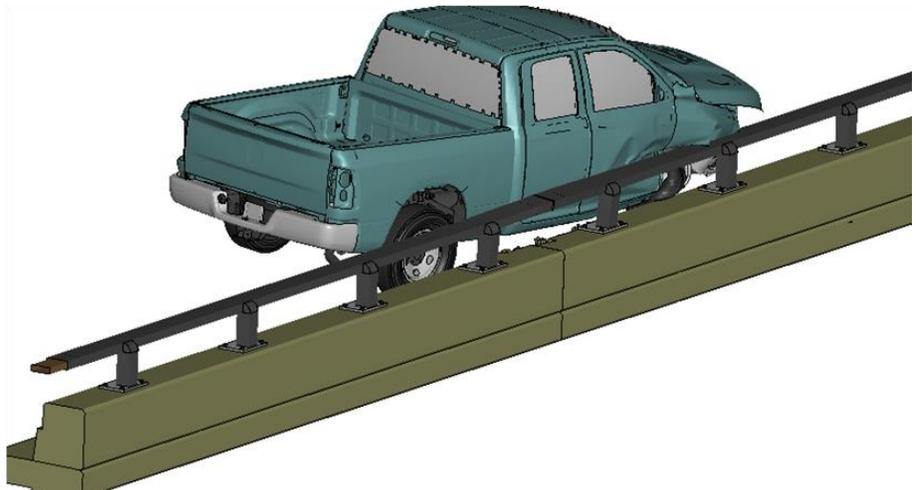
**Figure B-4. [Continued] Sequential views from analysis of MASH Test 3-11 at IP01 on CM-MTL3 Bridge Rail with Safety-Curb Design from oblique viewpoint.**

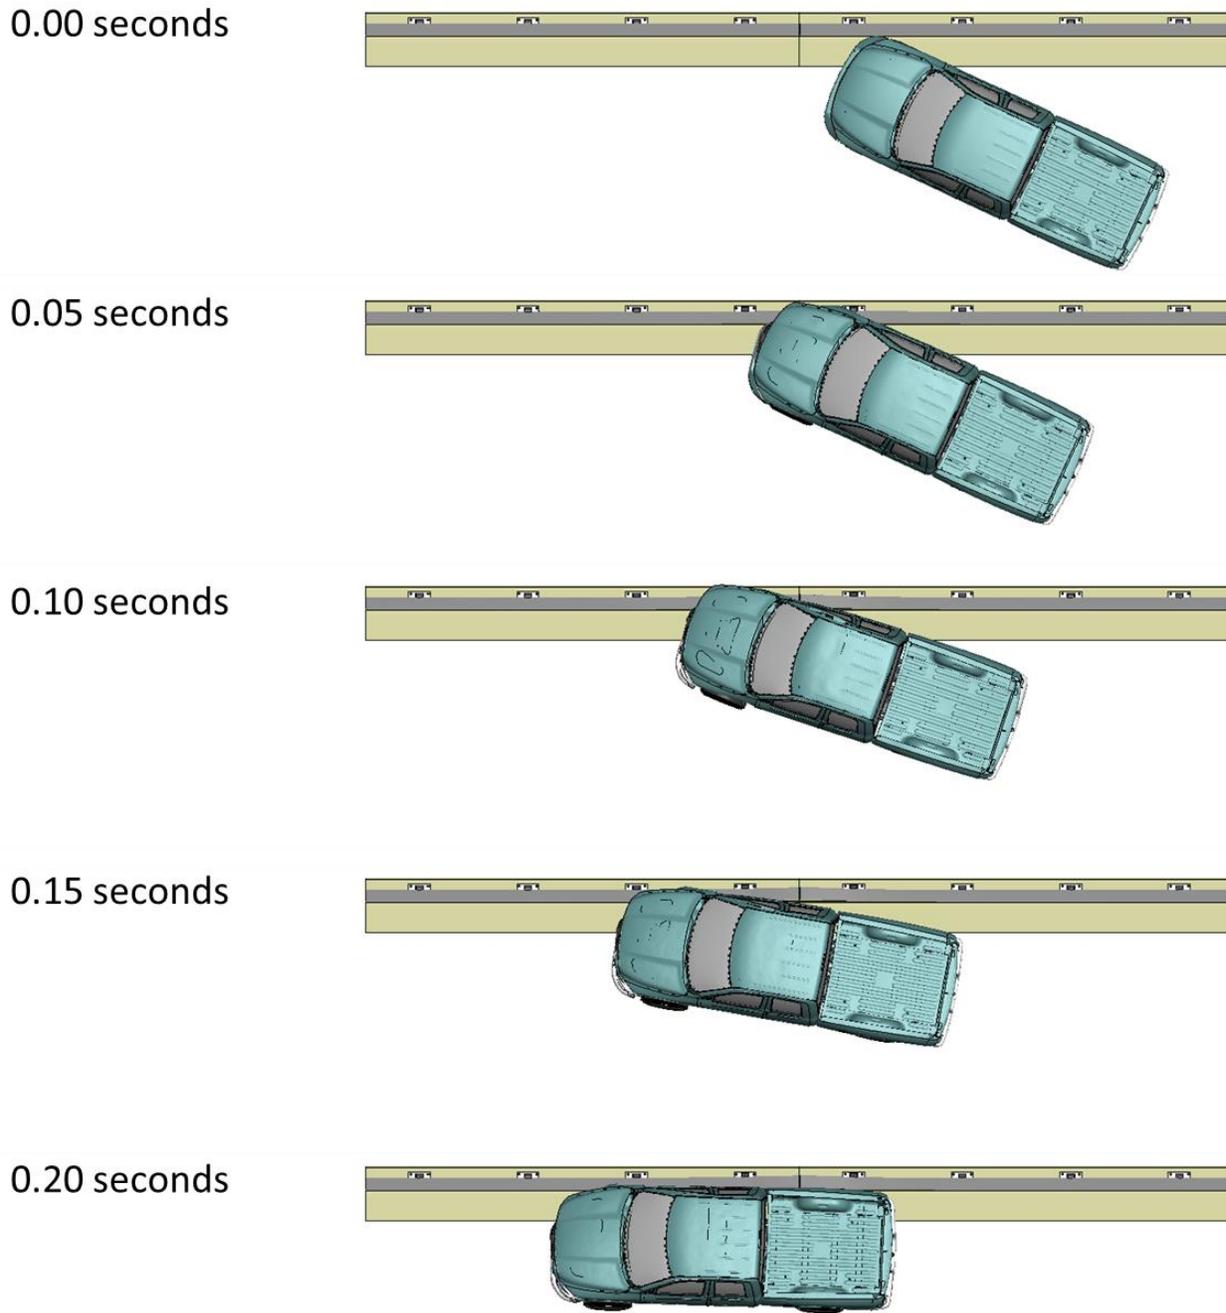
**Figure D-1. Sequential views from analysis of MASH Test 3-11 RHT at IP01 on CM-MTL3 Bridge Rail with Vertical Face Design from an overhead viewpoint.**

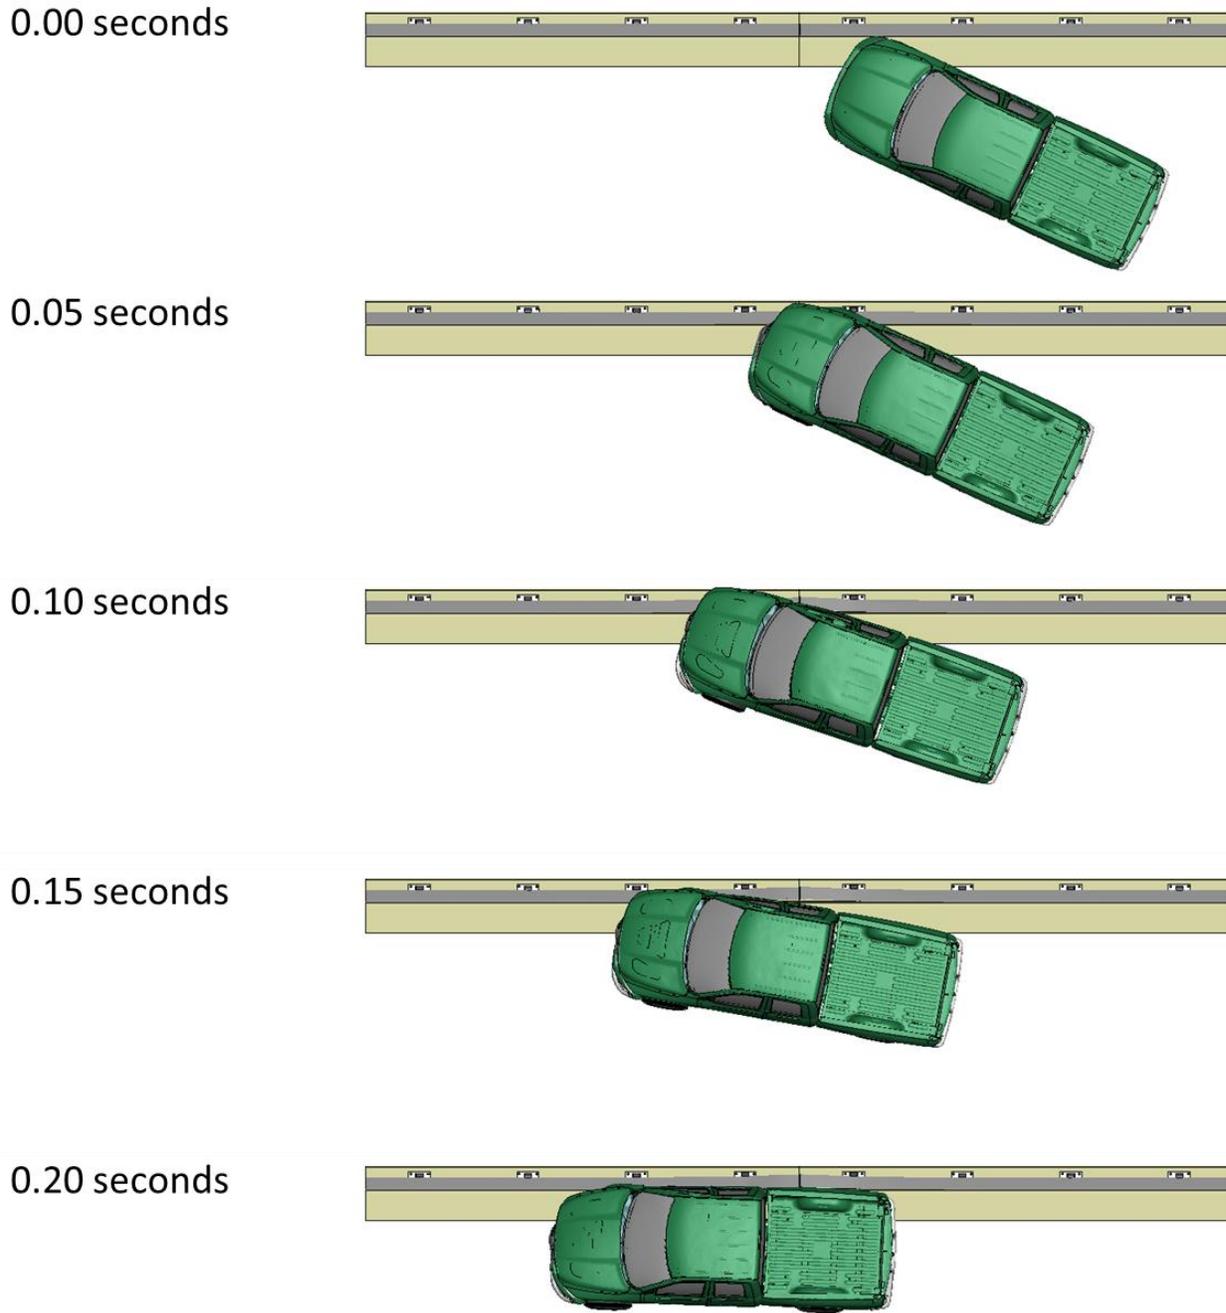
**Figure D-2. Sequential views from analysis of MASH Test 3-11 CSCM at IP01 on CM-MTL3 Bridge Rail with Vertical Face Design from an overhead viewpoint.**

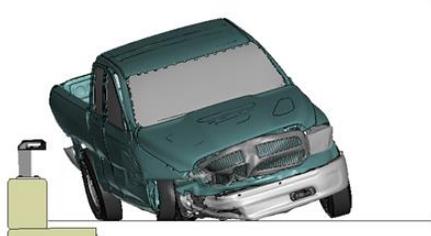
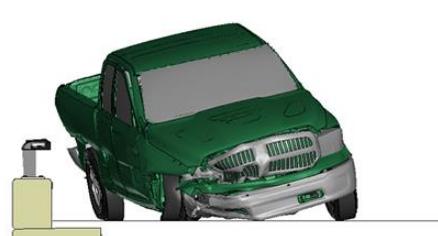
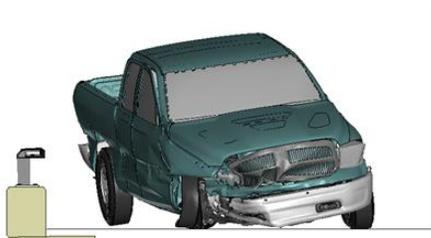
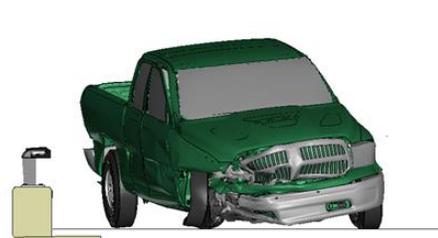
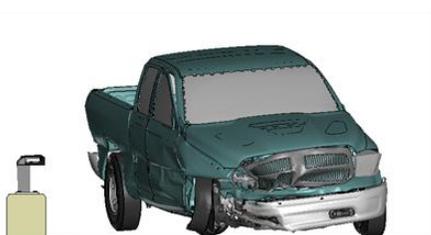
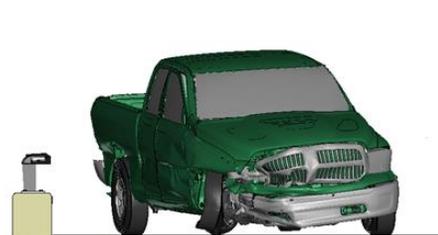
**Figure D-3. [Continued] Sequential views from analysis of MASH Test 3-11 at IP01 on CM-MTL3 Bridge Rail with Vertical Face Design from a downstream viewpoint. RHT on left, CSCM on right.**

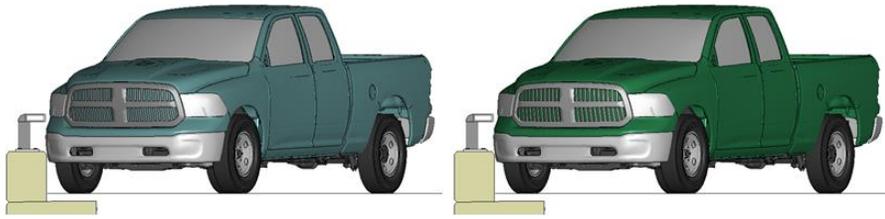
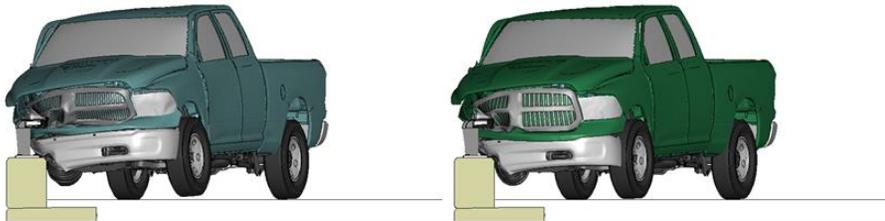
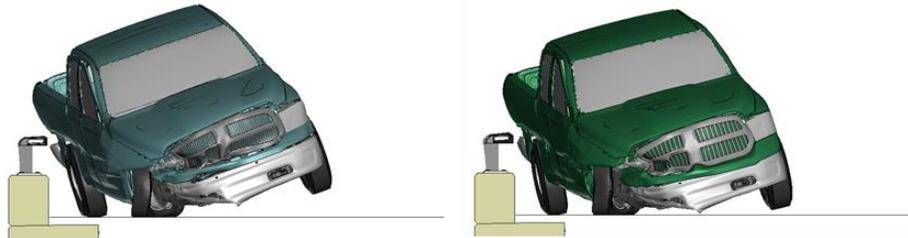
**Figure E-2. [Continued] Sequential views from analysis of MASH Test 3-11 CSCM at IP02 on CM-MTL3 Bridge Rail with Vertical Face Design from an overhead viewpoint.**

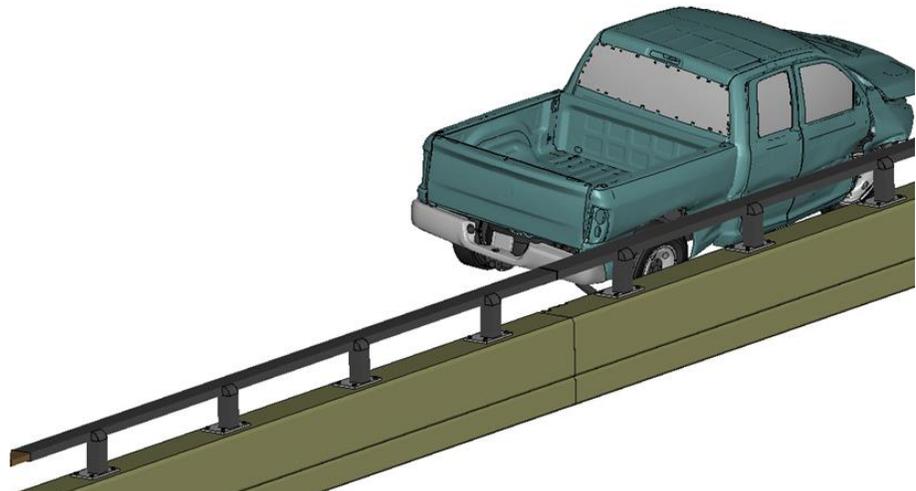
**Figure E-5. [Continued] Sequential views from analysis of MASH Test 3-11 RHT at IP02 on CM-MTL3 Bridge Rail with Vertical Face Design from an oblique viewpoint.**

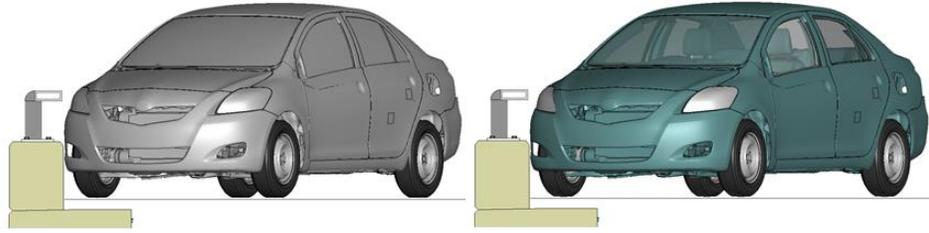
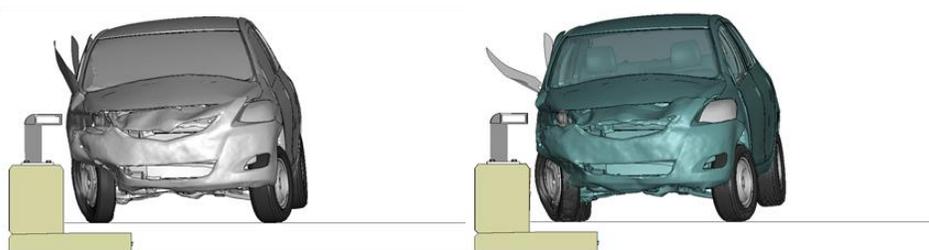
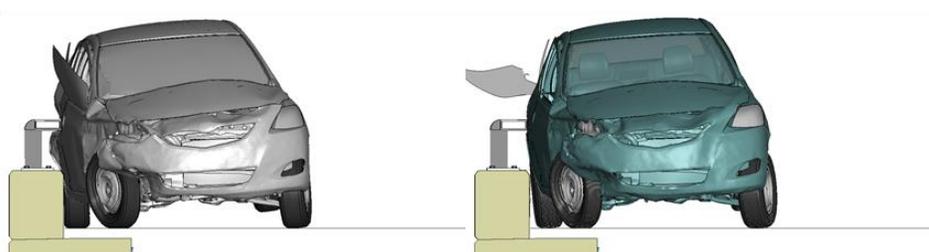
**Figure F-2. [Continued] Sequential views from analysis of MASH Test 3-10 CSCM at IP01 on CM-MTL3 Bridge Rail with Vertical Face Design from an overhead viewpoint.**

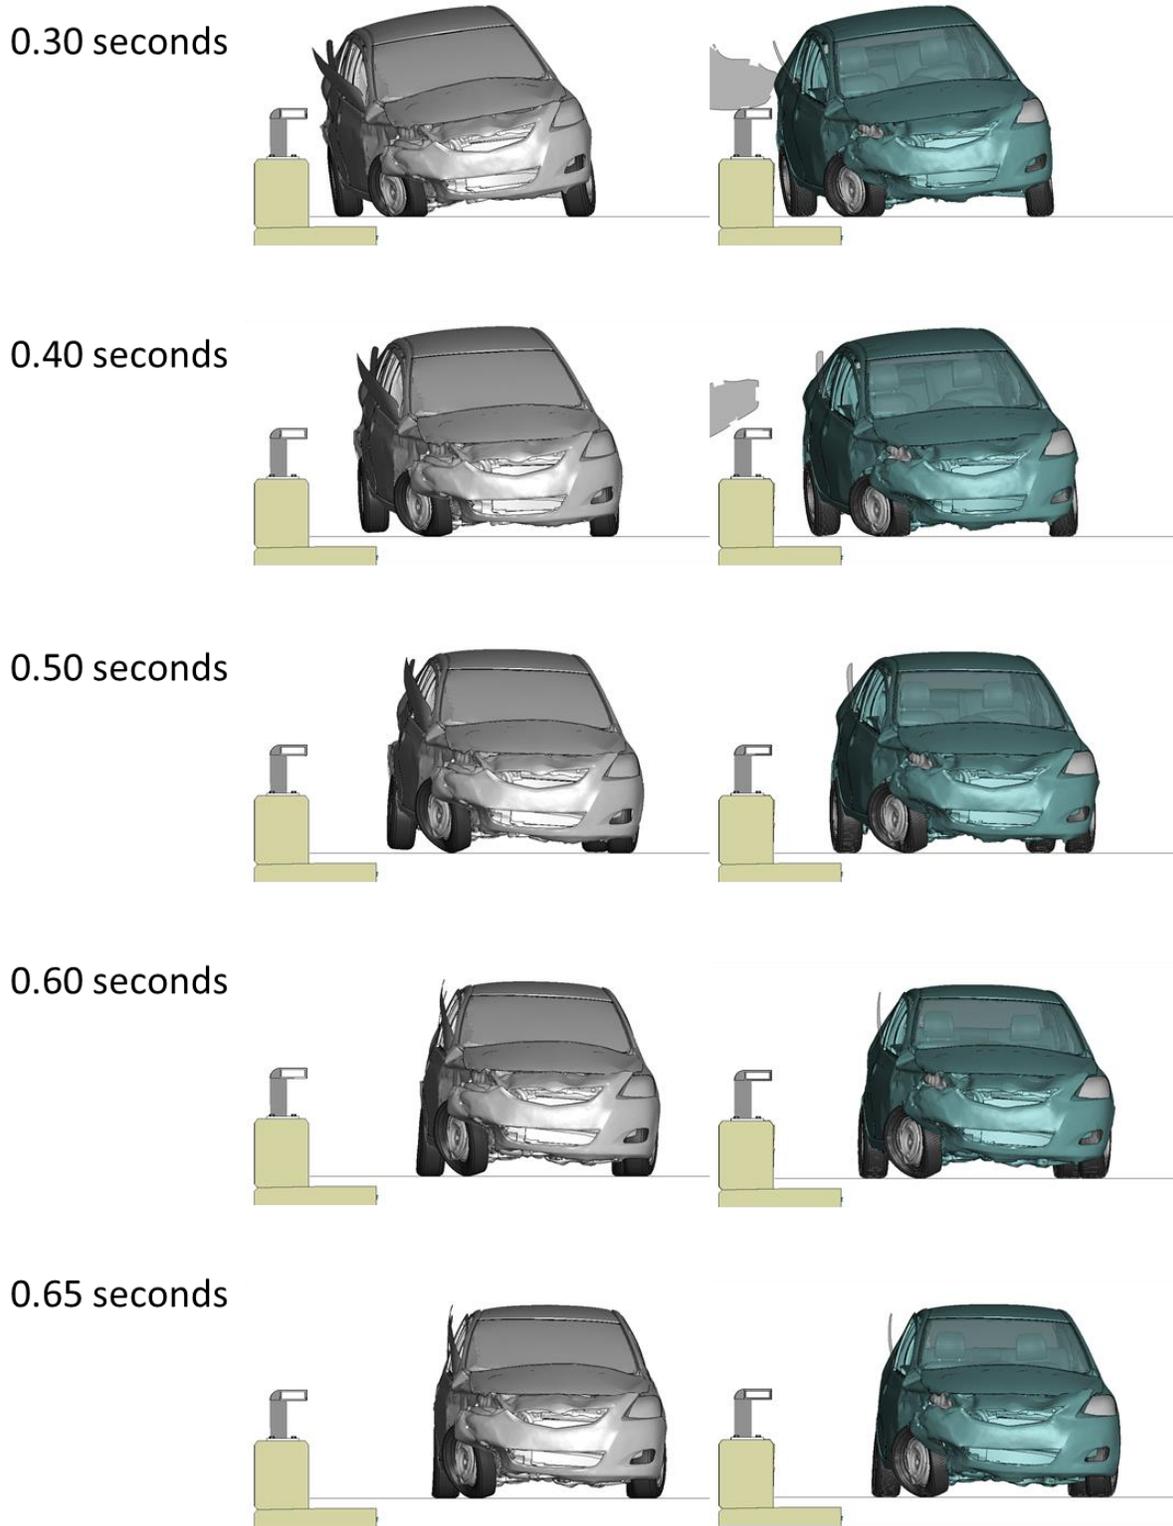
**Figure F-3. [Continued] Sequential views from analysis of MASH Test 3-10 at IP01 on CM-MTL3 Bridge Rail with Vertical Face Design from a downstream viewpoint. RHT on left, CSCM on right.**

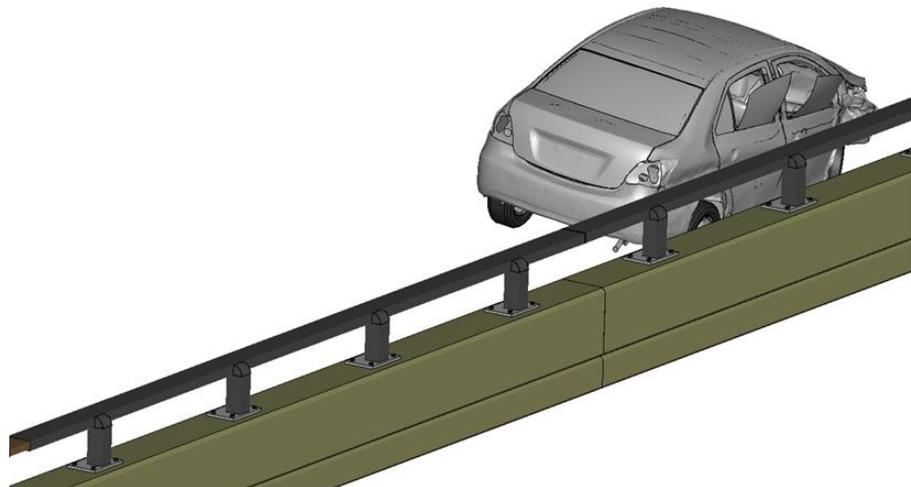
**Figure F-5. [Continued] Sequential views from analysis of MASH Test 3-10 RHT at IP01 on CM-MTL3 Bridge Rail with Vertical Face Design from an oblique viewpoint.**

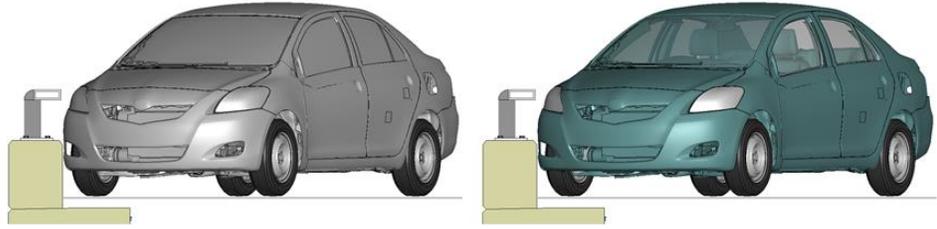
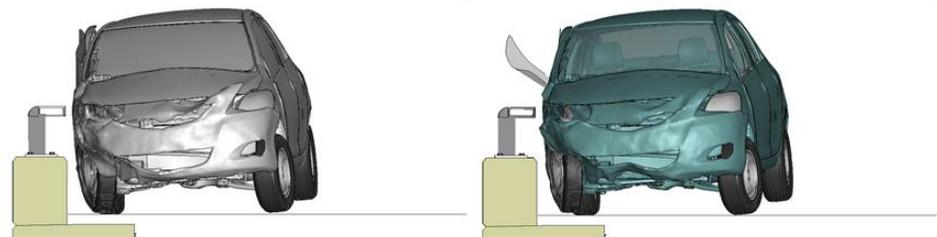
**Figure G-2. [Continued] Sequential views from analysis of MASH Test 3-10 CSCM at IP02 on CM-MTL3 Bridge Rail with Vertical Face Design from an overhead viewpoint.**

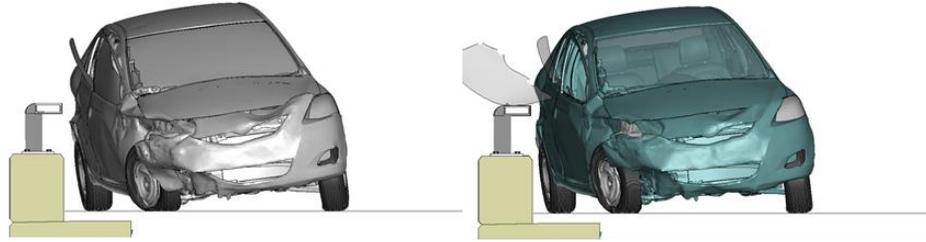
**Figure G-3. Sequential views from analysis of MASH Test 3-10 at IP02 on CM-MTL3 Bridge Rail with Vertical Face Design from a downstream viewpoint. RHT on left, CSCM on right.**
