A Guide for W-Beam Guardrail Damage Assessment

A Field Manual for
Highway Maintenance Personnel

National Cooperative
Highway Research
Program
Project 22-28

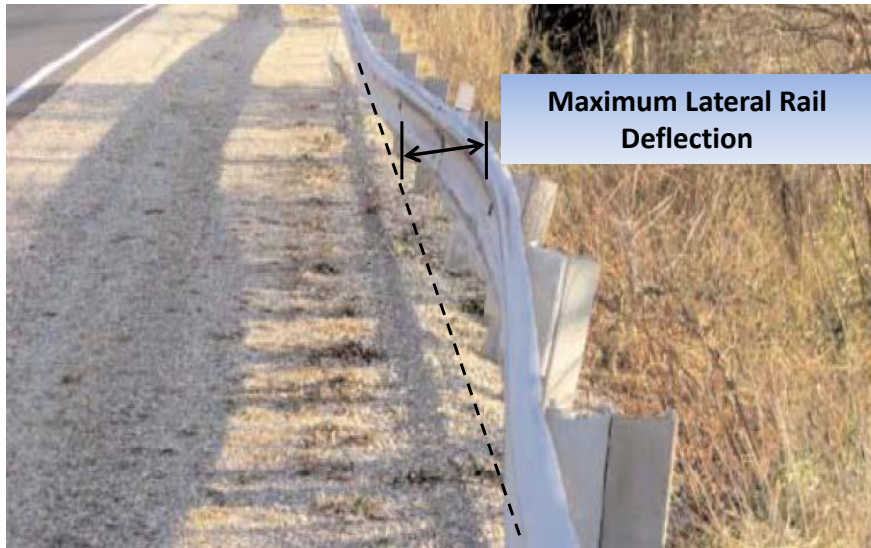
Lateral Rail Deflection

Maximum lateral deflection =	}	> 9 inches	High
		6 – 9 inches	Med
		< 6 inches	Low

Although the effects of rail damage differ between the modified G4(1S) steel post guardrail and the G4(2W) wood post guardrail, the threshold of damage that constitutes the need for repair is essentially the same for both systems; thus the relative repair thresholds defined by Gabler *et al.* in NCHRP Report 656 are considered valid for both systems and are adopted here.

Rail deflections exceeding 9 inches may significantly affect the ability of the guardrail systems to contain and redirect vehicles. Beyond this critical deflection, the G4(2W) was shown to be susceptible to rail rupture, while the modified G4(1S) had an increased probability of barrier override. The relative priority for repair is high for those cases.

Rail deflections of 6 to 9 inches were found to compromise system performance, but the guardrails should function adequately under a majority of impacts. The relative priority for repair is medium for those cases.

At rail deflections less than 6 inches, the guardrails are expected to remain fully functional.

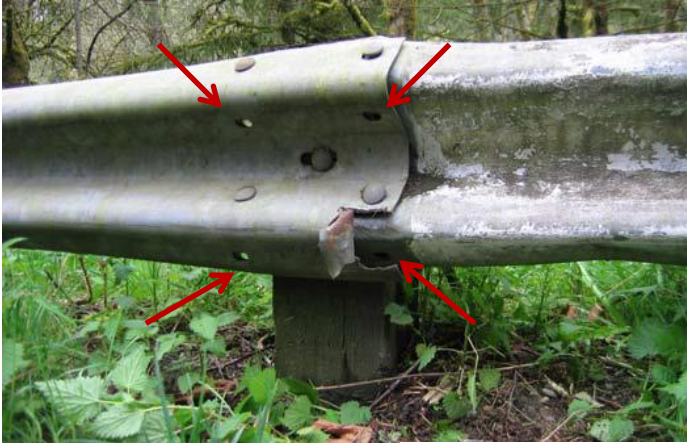
Splice Damage

- Missing bolt
- Visibly missing underlying rail material at bolt location
- Bolt severely gouging rail
- Bolt torn through rail
- Loose bolt

- Damage at two or more splice-bolt locations High
- Damage at a single splice-bolt location Medium

It is recommended that the repair threshold for splice damage include splice-bolts: missing, loose, damaged, severely gouging or torn through the rail, or visibly missing any rail material under the bolt. When any of these damages occur at a single splice-bolt location the recommended repair priority is medium. When any of these conditions occur at two or more splice-bolt locations the recommended repair priority is high.

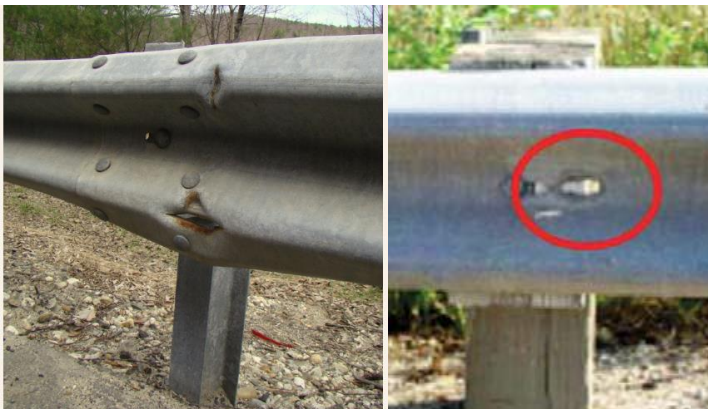
Rail Holes / Horizontal Tears

- Any size hole or tear at top or bottom edge
- Hole with height > 1"
- Three or more holes or tears on a panel
 - 1 to 2 holes with height < 1"
 - Horz. Tears with Length > 12"
 - Horz. Tears with height 0.5 – 1"

Any size hole or horizontal tear (e.g., from weathering, rust, or impact damage) located at the top or bottom edge of the rail has the potential for causing a tear to propagate vertically and is therefore considered high priority for repair. Also, for holes with heights greater than 1 inch, or when there are three or more holes or horizontal tears on a w-beam panel, the relative priority for repair is classified as high.

Pendulum tests have shown that horizontal tears located between the top and bottom corrugations of a w-beam rail do not notably reduce the tensile capacity of the rail. Such tears, however, can result in a part of the vehicle (e.g., front bumper) passing through the tear, exposing the component to direct impact against the guardrail posts, or further extending the tear as the vehicle progresses forward along the rail, increasing the potential for rail rupture.

For horizontal tears located between the top and bottom corrugations with lengths greater than 12 inches, or with heights between 0.5 – 1 inch, or when there are 1 to 2 holes with height less than 1 inch on a single panel, the performance of the guardrail may be compromised but should function adequately under a majority of impacts. Thus the relative priority for repair is classified as medium for those cases.

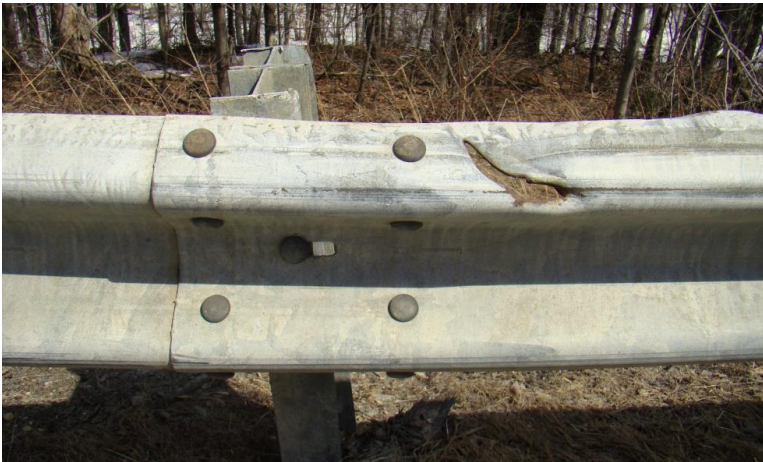
Vertical Tears

Any size vertical tear → **High**

A vertical tear on any part of a w-beam rail may significantly affect the ability of the guardrail system to contain and redirect vehicles. A vertical tear, particularly on or near the edge of the rail, has a high probability of propagating (i.e., extending/growing) during impact and resulting in complete rupture of the rail. All vertical rail tears, therefore, indicate high priority for repair.

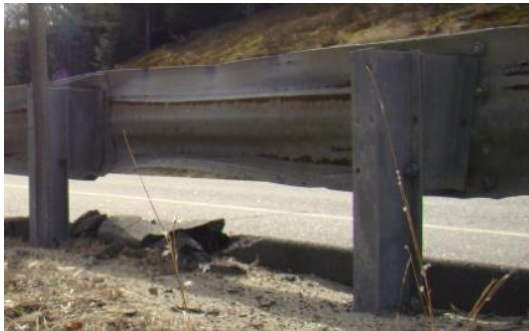
Field Example of
Rail Flattening

Rail flattening and rail crush have not been shown to significantly affect guardrail performance, and therefore are not considered as high priority for repair.

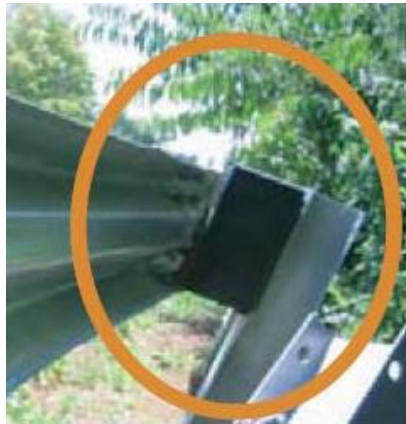
Posts Separated from Rail

- Post/rail separation > 3"
- 2 or more posts separated from rail

This damage mode has not been shown to significantly affect guardrail performance and, therefore, is not considered to warrant high priority for repair. However, engineering judgment should be used on a case by case basis.

For the case of a single post separated less than 3 inches from the rail, the system should remain fully functional. However, when two or more consecutive posts are separated, or when post/rail separation for a single post exceeds 3 inches, guardrail performance may be compromised. The relative priority for repair in such cases is generally medium; however, such damage often denotes the existence of other damage modes.

Post and rail separation rarely occurs without post and rail deflection or damage to other components. When post/rail separation greatly exceeds 3 inches or if multiple posts are separated from the rail, it is recommended that other aspects of the system be critically evaluated (e.g., lateral deflection, missing or damaged blockouts, etc.).

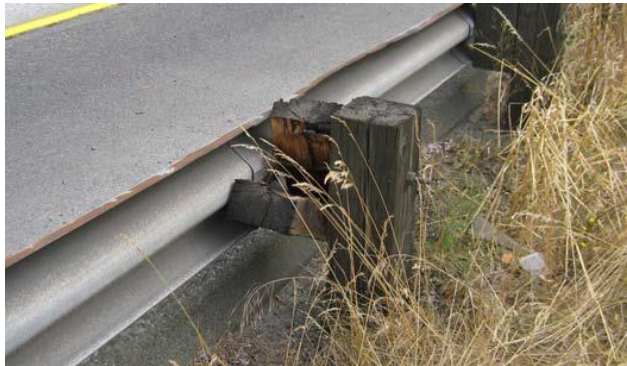
Blockout Condition

Any blockouts:

- Missing
- Cracked across grain
- Split through post hole
- Rotted

This damage mode has not been shown to significantly affect guardrail performance and, therefore, is not considered to warrant high priority for repair. However, when one or more blockouts are missing, cracked across the grain, split vertically through the post-bolt hole or rotted, there is an increased potential for the rail to directly contact the posts during a collision, which may increase the propensity for rail tears (particularly for rail contact with steel wide-flange posts).

For this damage mode, the guardrail is expected to perform adequately for the majority of impact cases. The relative priority for repair is classified as medium.

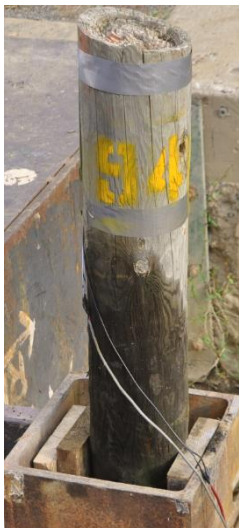
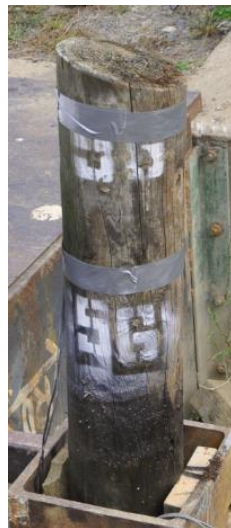
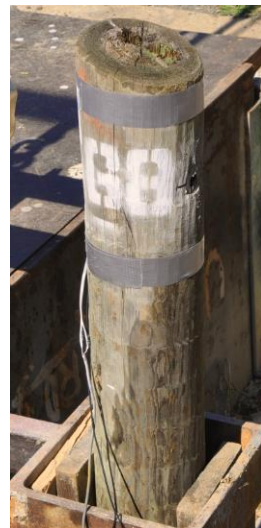
Visual Cues (see Commentary)

DL3		DL2		DL1	
Score	Criteria	Score	Criteria	Score	Criteria
Force (k): 3.8	< 9	7.6	7-13	14.8	12-15
Energy (k-in): 5.3	< 20	21.3	20-30	32	26-40
Resi: 0.24	< 0.57	0.67	0.57 - 0.83	0.95	0.83 - 1.0

DL3: Significant deterioration at top of post is usually evident. Deterioration is often deep (>1”) and covers the full cross-section of the post. Mildew or mold is often present on the side of the post near the ground line; and the post is audibly very soft (punky) when struck with a hammer near the groundline.

DL2: Often marked by shallow deterioration at top of post (<1”), extending over most if not all the cross-section. Post is audibly soft but not punky when struck by a hammer.

DL1: Generally there is no deterioration evident at the top of the post. In some cases, however, signs of deterioration may exist near the top-center of post, but will not extend to the outer shell. The post is relatively sound when struck with a hammer.

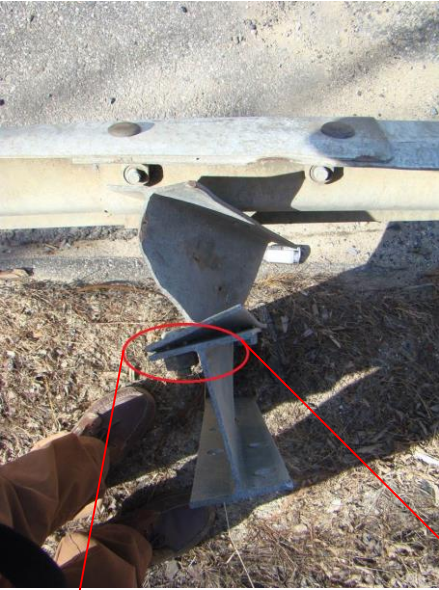
Steel Post Condition

One or more posts missing or with metal tears

For the steel posts of the G4(1S) guardrail, the relative priority for repair is classified as high when any posts are missing or have metal tears in them. The guardrail will not function properly with these damages and the posts must be replaced.

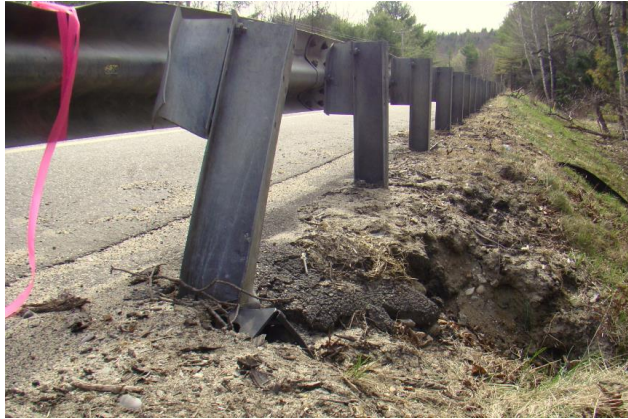
Erosion at a Single Post within a Four-Post Span:

Erosion =	$\left\{ \begin{array}{l} \geq 12'' \\ 9 - 12'' \end{array} \right.$	High
		Med

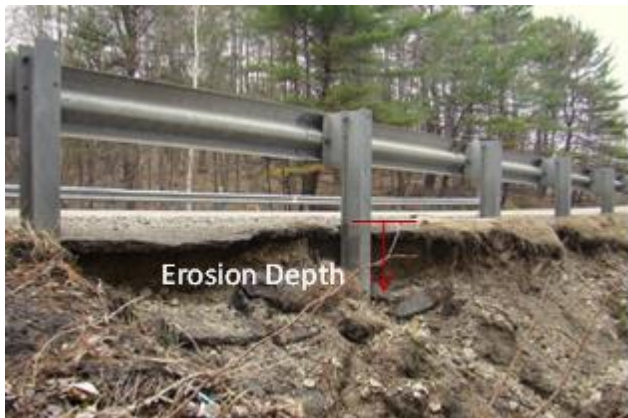
Erosion at Multiple Posts within a Four-Post Span:

Erosion =	$\left\{ \begin{array}{l} \geq 6'' \\ 4 - 6'' \end{array} \right.$	High
		Med

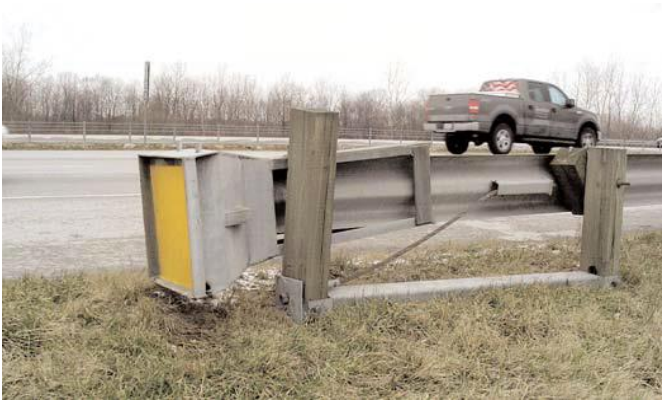
Misaligned or missing screws:

The alignment of the impact head on an energy absorbing end-terminal is crucial to the functioning of the system during end-on impacts. Thus, if the terminal head is misaligned or not properly attached to the end-post, then the system should be repaired immediately. In most cases the impact head is attached to steel posts using bolts, whereas lag screws are used for attachment to wood posts.

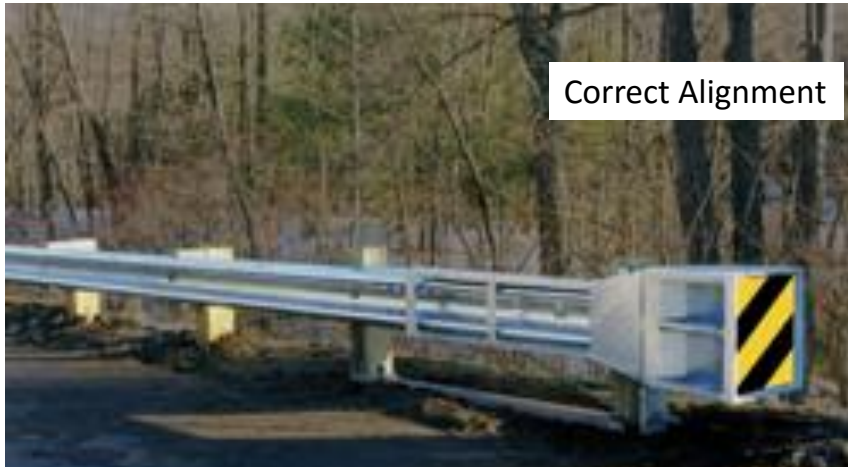
Correct Alignment

Note: Attachment hardware for the impact head will vary depending on manufacturer.

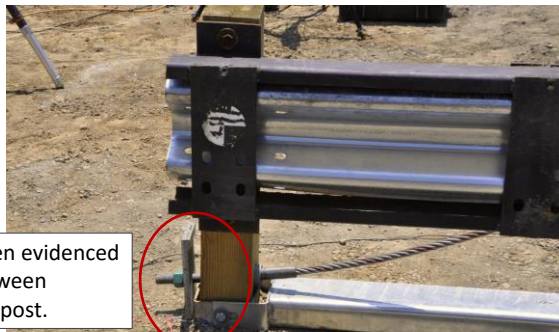
Loose Cable:

$$\text{Slack} = \frac{\Delta z}{2} = \begin{cases} >3'' & \text{High} \\ 2''-3'' & \text{Med} \end{cases}$$
